## Tomb no. GB 27 (Gabra no. M 09c/SE) facade

## Tomb no. GB 27 (Gabra no. M 09c/SE) inside

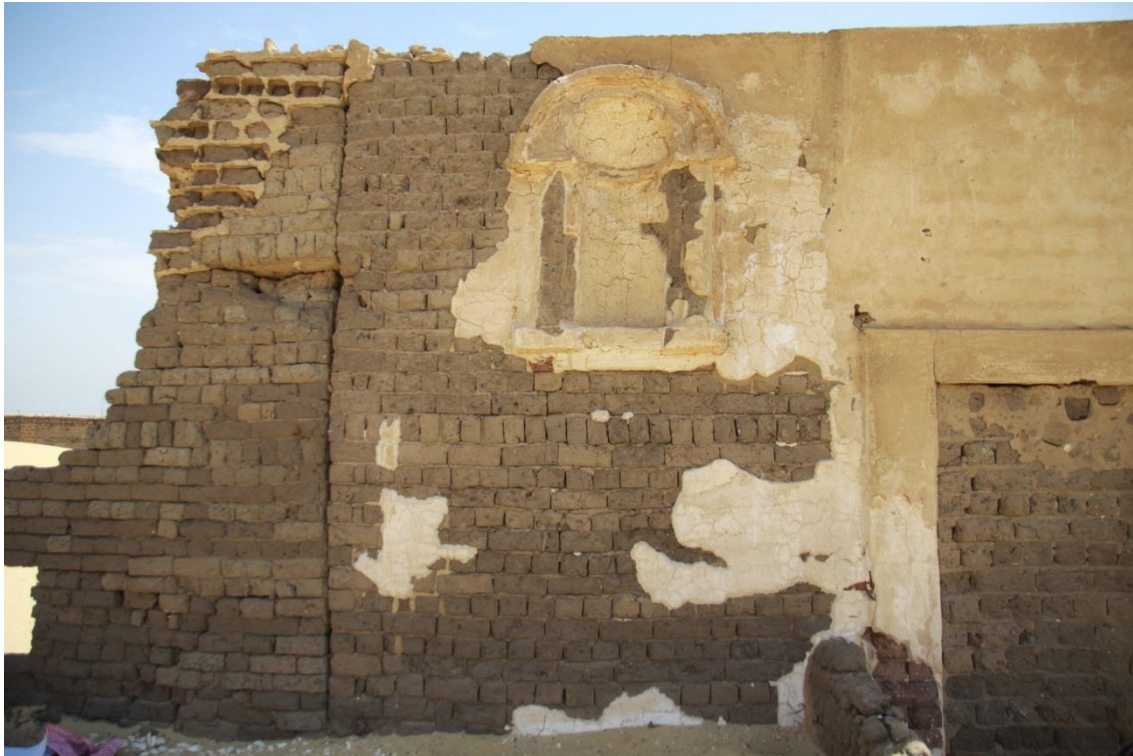
Emergency measures have been carried out to prevent further decay. The facade is exposed to the elements and human action. In this respect, it would be desirable to establish maintenance and monitoring programme for the future.

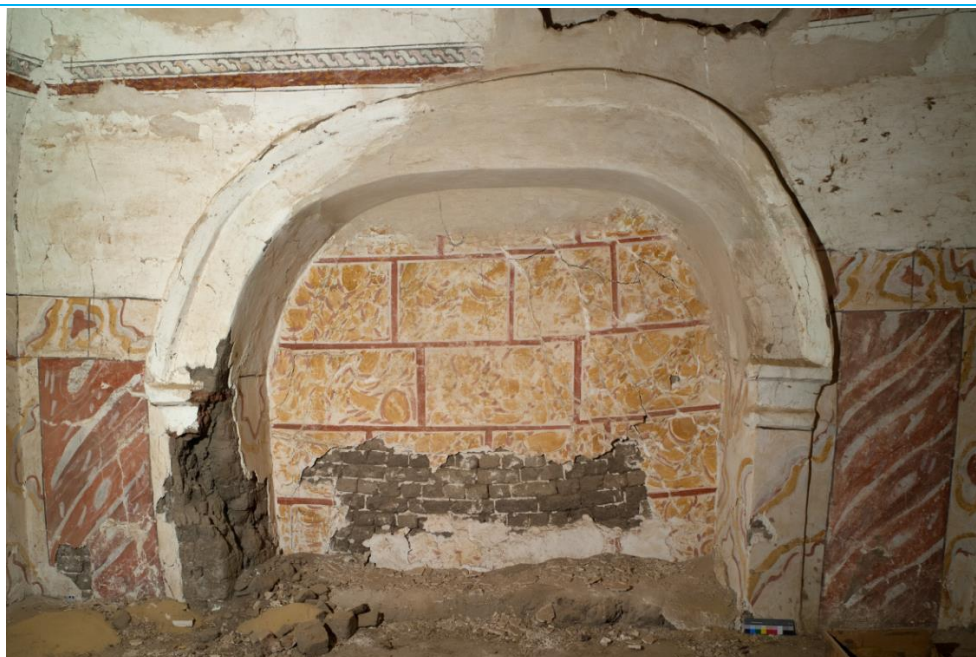
The plaster layers, especially on the northern wall, are partially lost and expose the sun-dried clay brick masonry (adobe). Where visible, the adobe masonry shows a structurally destabilised and sanding surface. There is a bigger damage in the masonry structure in the eastern frame of the big arched niche. Plaster fragments can be found on the floor below the walls.

The architectural surface is lined with cracks. Additionally, the plaster layers are detached from the adobe masonry, being endangered to falling off. In particular, the plaster layers in the big arched niche are particularly fragile. Collapsed plaster fragments could be found on the floor.

The paint layers are reduced. Partially the paint layers show deterioration phenomena like powdering. There is a layer of dust on the whole structure and a layer of bat excrements on the floor.

An intervention is necessary to halt active deterioration and preserve the original plaster and wall painting.

The following steps of emergency measures were done in the field schools of 2012 and 2014. The room and all architectural surfaces were cleaned. Fragile paint layers were structurally consolidated on the eastern and northern walls. Further emergency measures were concentrated on the most endangered plaster layers in the big arched niche in the northern wall. The consolidation of the adobe masonry surface provided a solid structure for the treatments to follow. For temporary protection fragile parts of the wall painting were faced with Japanese paper and cellulose-ether glue. The many fallen-off plaster fragments were secured, documented and stored separately.

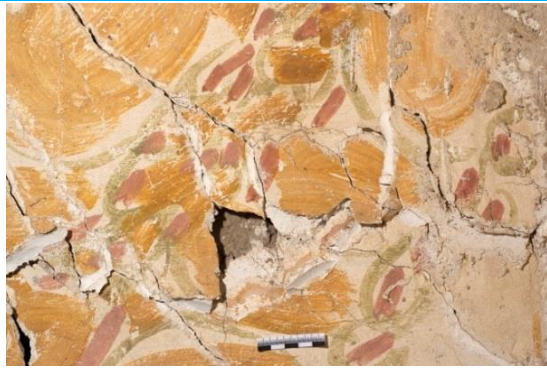
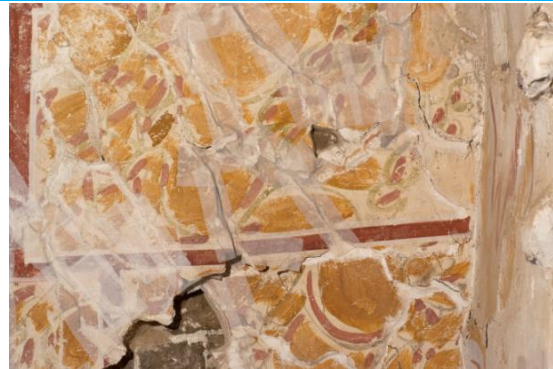
Fragile parts of the wall painting were facing with Japanese paper and cellulose-ether glue. Further treatment is essential to guarantee long-term conservation.

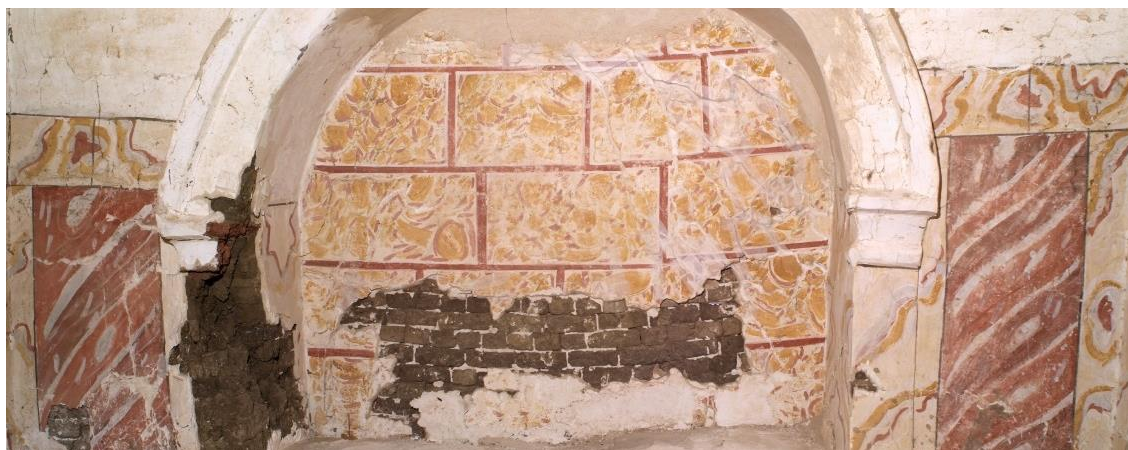
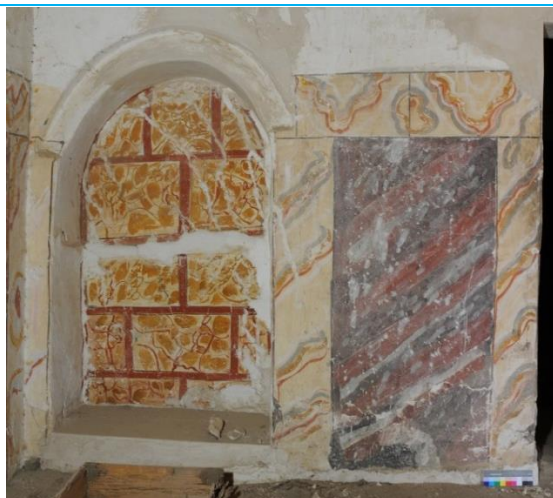
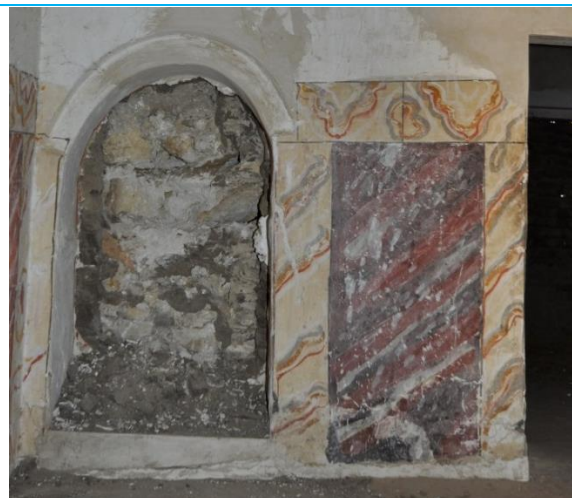
In June 2018 the paint and plaster layers in the niche in the eastern wall were permanently destroyed. In this respect, it would be desirable to continue the emergency measures and to establish maintenance and monitoring programme for the future.
