## Tomb no. GB 42 (Gabra no. M 18/CP)

### Description of the interior design

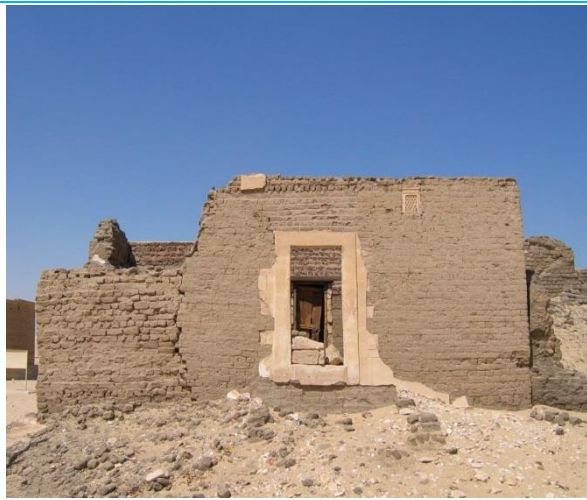
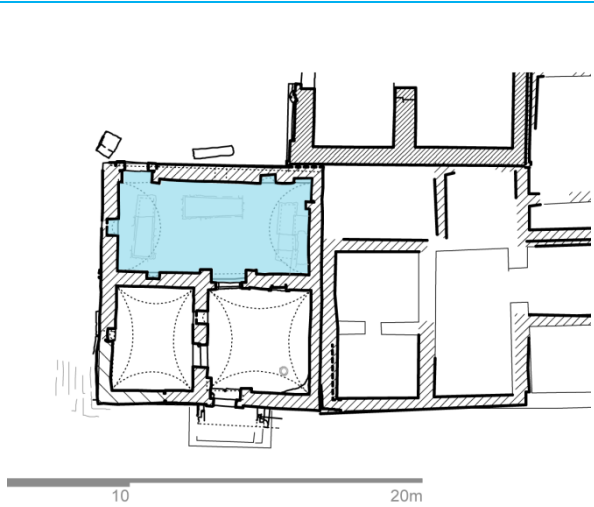
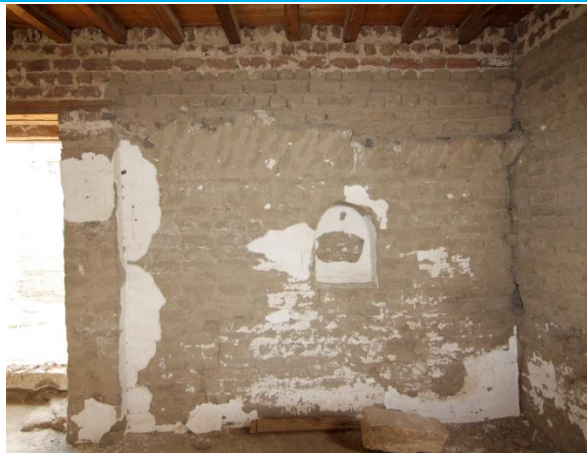
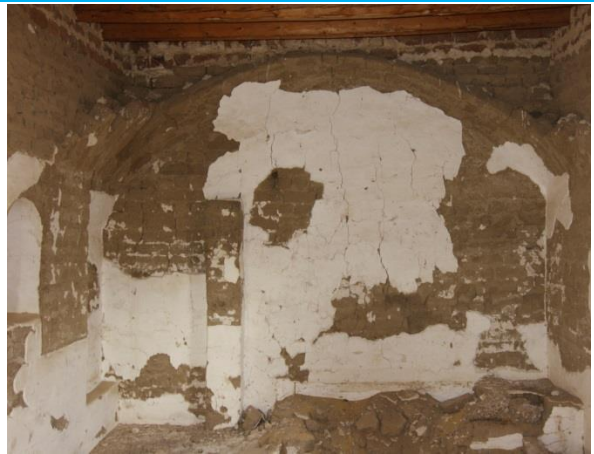
The plaster layers are partially lost and expose the sun-dried clay brick masonry (adobe). Where visible, the adobe masonry shows a structurally destabilised and sanding surface. There are lots of insects' eating traces in the adobe structure.

The architectural surface is lined with cracks. Additionally, the plaster layers are detached from the adobe masonry, being endangered to falling off. In particular, the painted plaster layers on the northern wall are very fragile. Collapsed plaster fragments could be found on the floor.

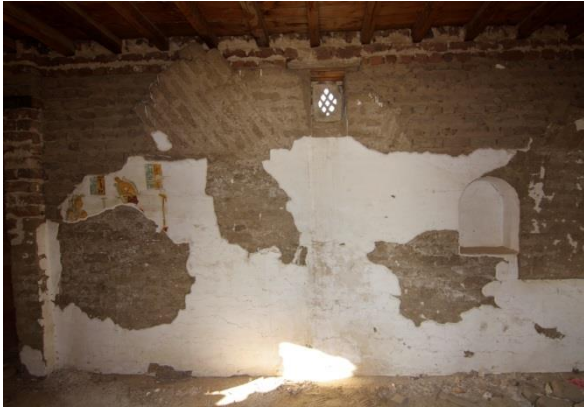
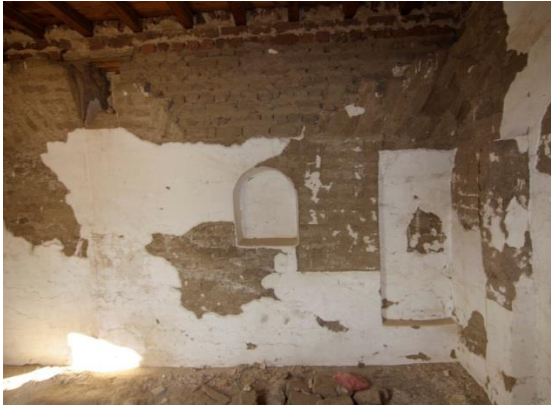
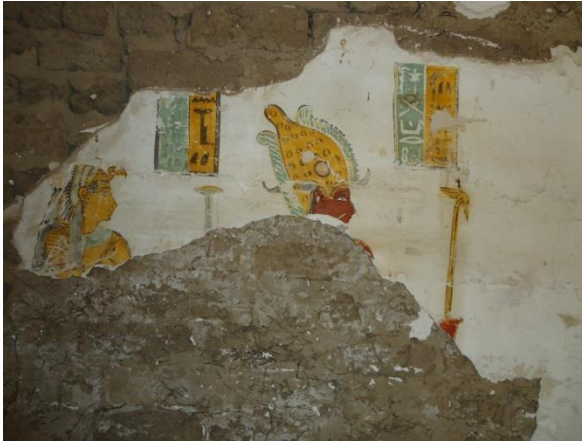
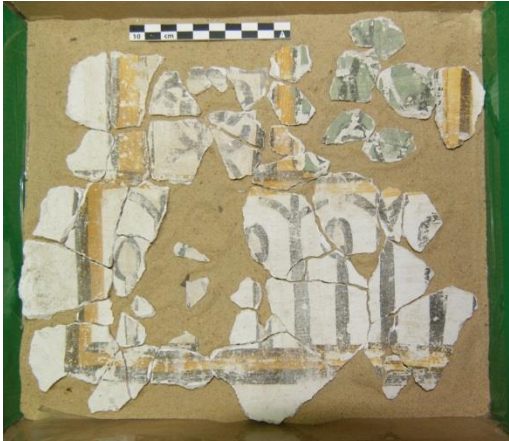
<b>Condition before treatment</b>	
<p>The paint layers are reduced. Partially, the paint layers show deterioration phenomena like flaking. There is a layer of dust and dirt on everything.</p> <p>An intervention is necessary to halt active deterioration and preserve the original plaster.</p>

<b>Treatment</b>	
<p>In the field school of 2014 the condition of the remaining plaster and paint layers was assessed and documented. The wall painting fragments, which collapsed in early 2013, were examined and grouped together, as far as possible. The fragments were secured, documented and stored separately.</p>	
<b>Condition after treatment</b>	
<p>Further treatment is essential to guarantee long-term conservation.</p> <p>The interior of this tomb house is open to the elements and human action. In this respect, it would be desirable to establish a maintenance and monitoring programme for the future.</p>
