## Existing wall paintings and their condition

Heike Pfund, 30.11.2018

### Wall Paintings in Tuna el-Gebel

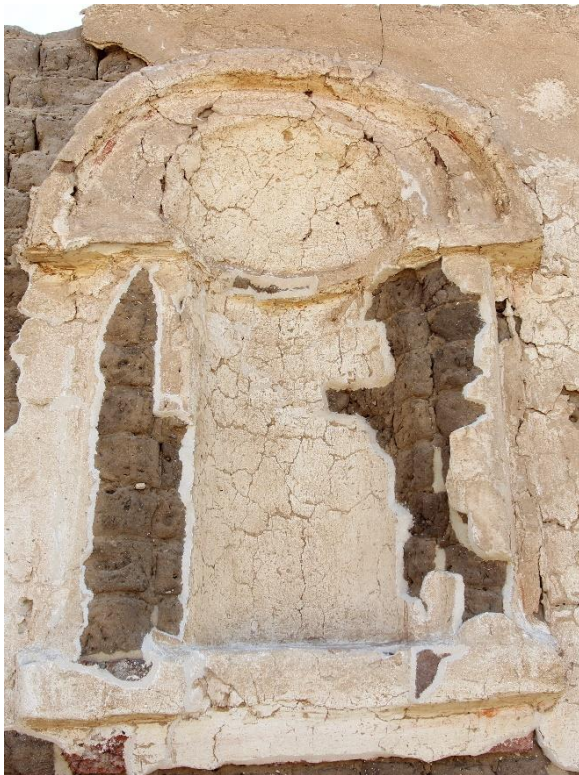
Fig.1 : GB 27 exterior, traces of red paint behind a later added adobe wall

Tomb houses were highly adorned with paintings. Interior paintings still remain in many tombs, though heavily fragmented. How exteriors were decorated is difficult to say, there is little evidence with far too few remains of plaster and paint. As remains of façade plaster with small traces of paint suggest, also exteriors were decorated with paintings (e.g. GB 27, figs.1, 2).

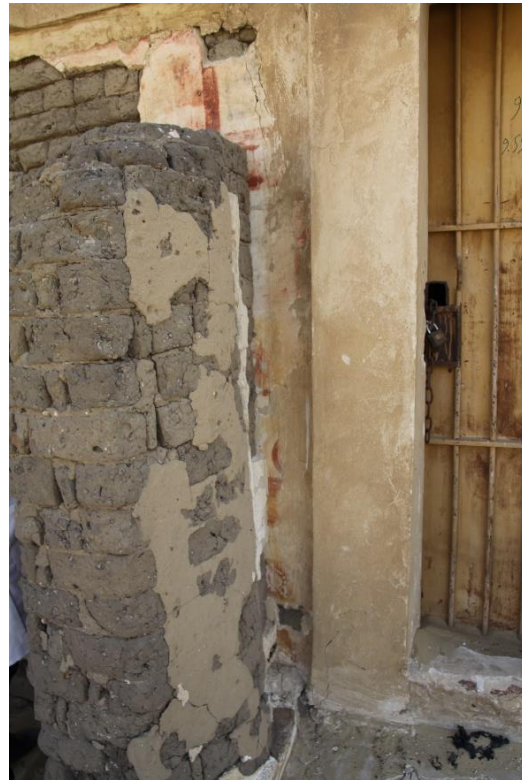
Fig.2 : GB 27 exterior, decoration, red paint,

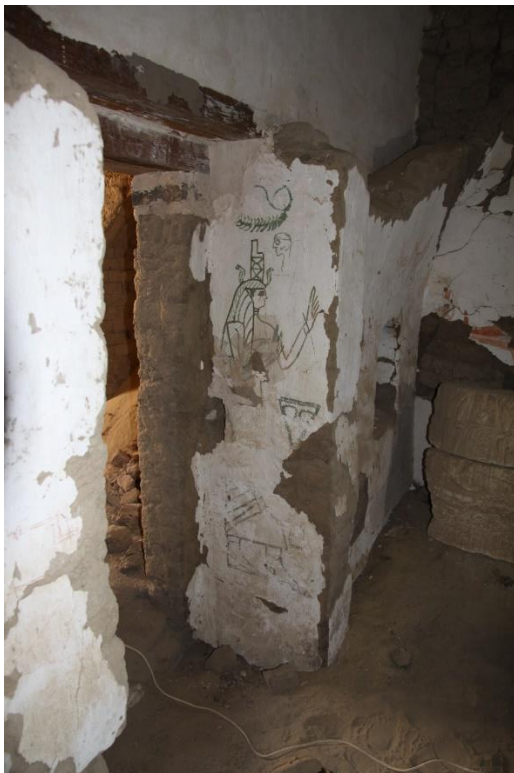
Fig.3: GB33, door from antechamber (left) to the main room

One obvious example for the development of techniques is tomb house GB 33. The ground floor room is plastered with mud plaster, decorated with single figurative scenes painted on layers of lime-wash, whereas the tomb built on top displays typical roman decoration in form of painted stone finishes on lime plaster (figs.3, 4 ).

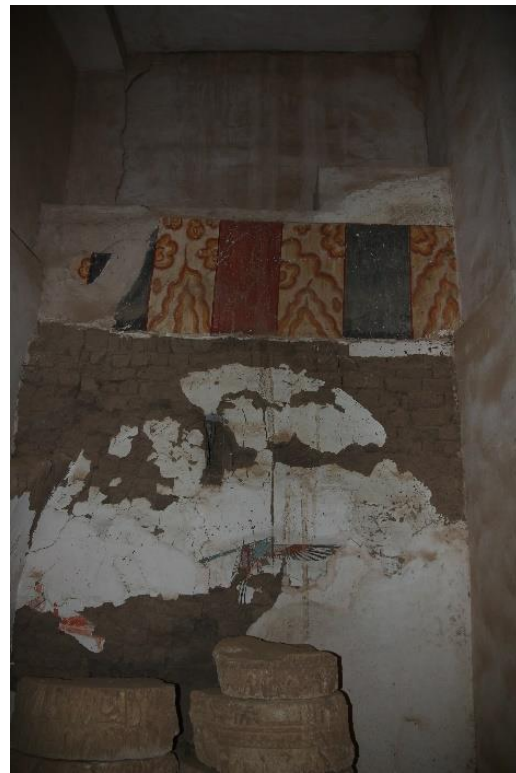
Fig.4: Vaulted ceiling missing, allowing the view to the first floor room

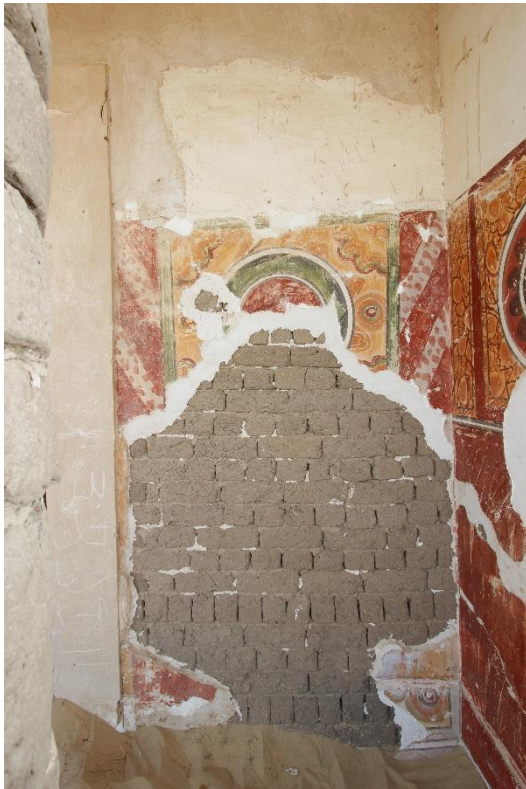
Fig.5: GB 7, open portico: losses in reachable areas

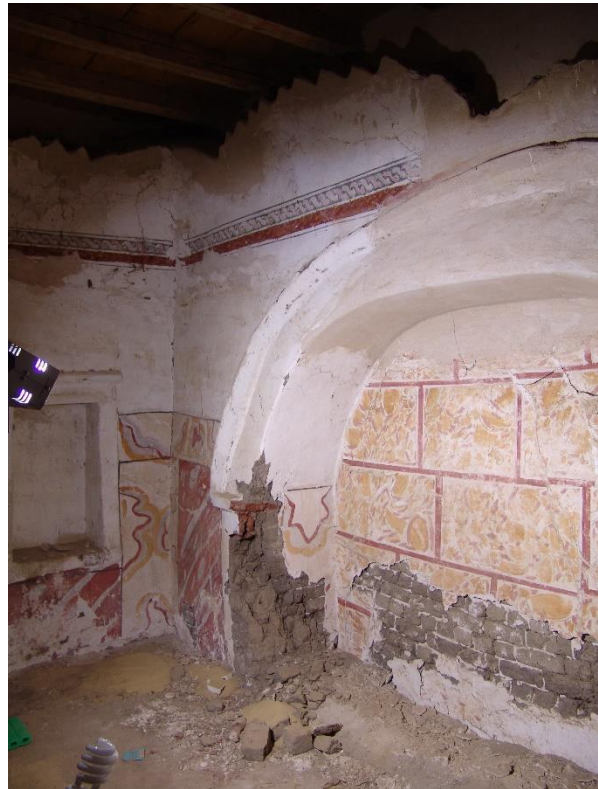
Fig.6: GB27, interior: compressed walls and cracked, detached plaster

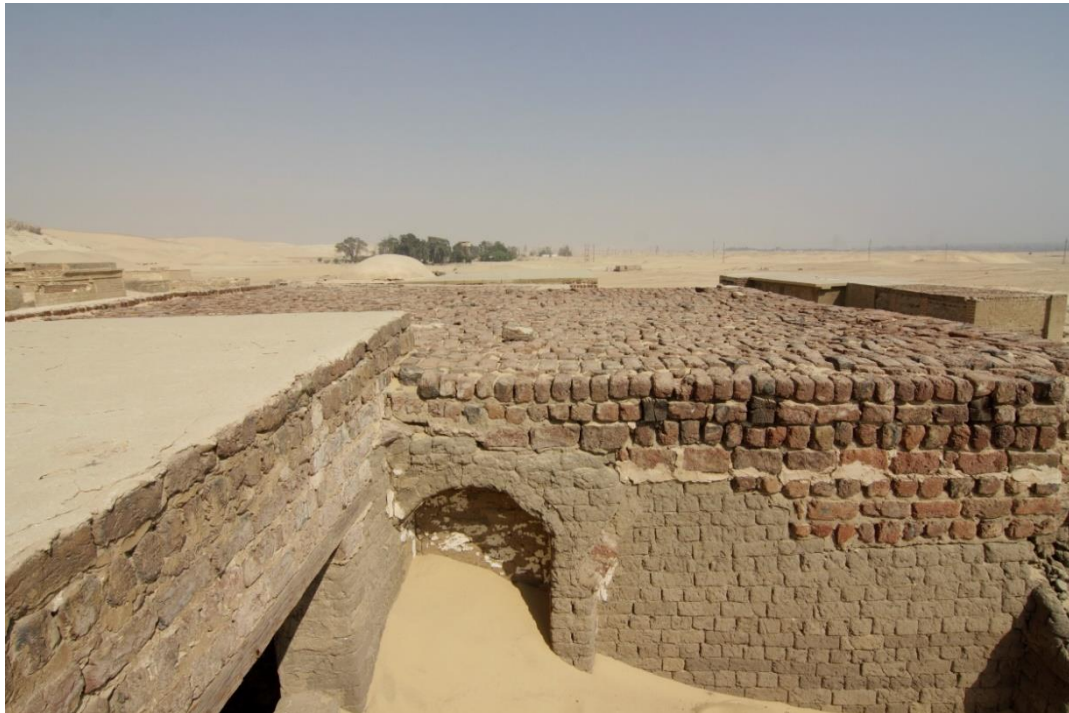
Fig.7: Exteriors of GB 24 (left) and GB 27 (right): walls were completed with burnt bricks, ceilings made of wood and covered by more burnt bricks, or coated with a cement layer

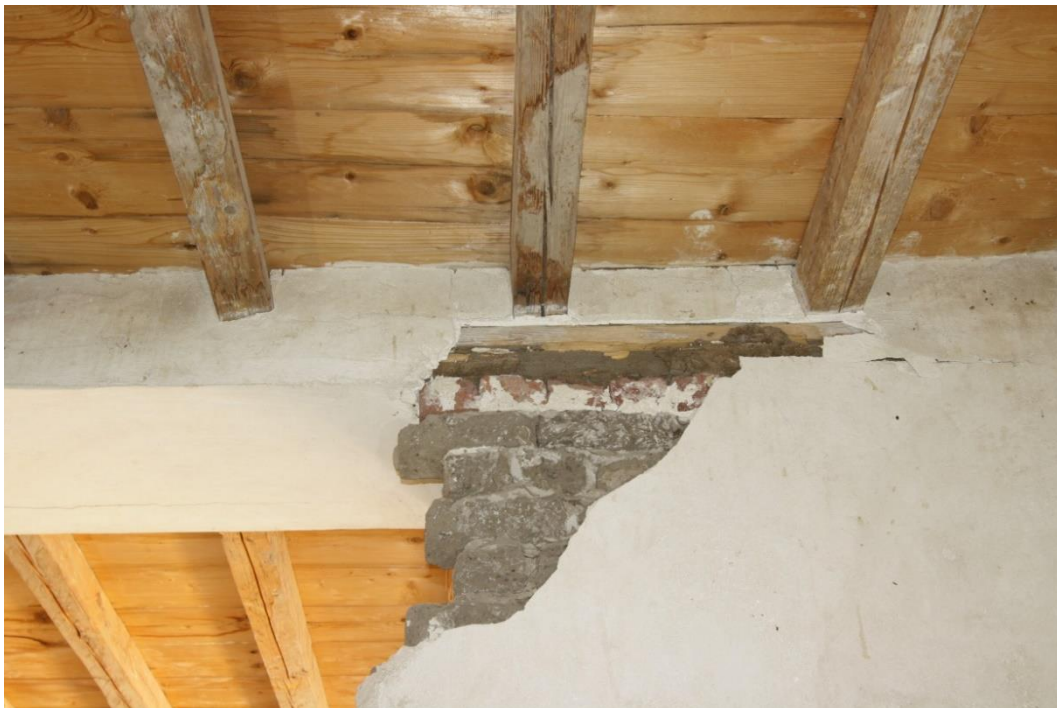
Fig.8: Interior of GB 27, revealing the structure of the modern roof

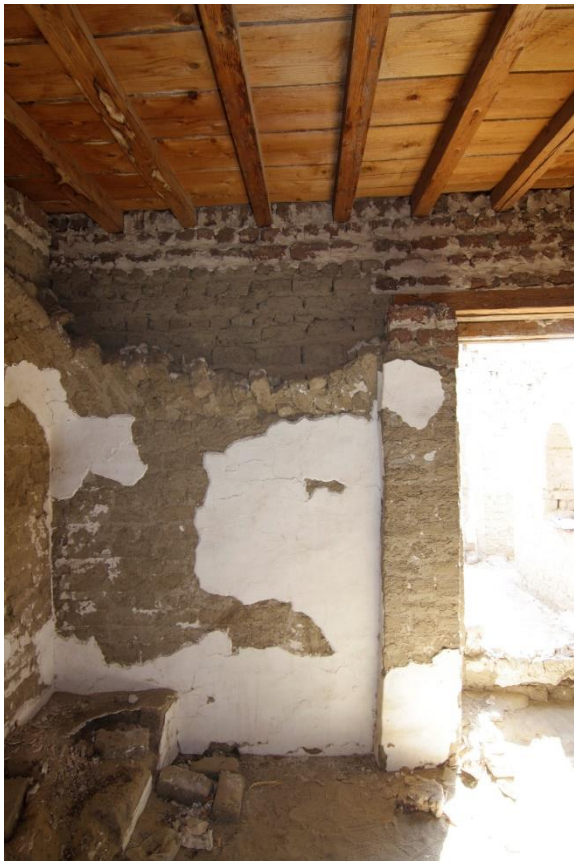
The new roofs are flat and quite heavy, resting mostly on the ancient adobe brick walls. If walls were incomplete, adobe bricks and burnt bricks were randomly used to complete the walls before adding the roof (fig.9). Roofs were constructed of wooden beams and planks, bricks, tiles, plaster and cement, even steel beams had been used for some roofs. After constructing the roofs, interiors were repaired, by rendering areas where original plaster was missing with a white smooth but stiff material, most likely containing gypsum. For exteriors another type of repair plaster was used presumably containing cement.

Fig.9: GB 42, wall repaired by adobe and burnt bricks

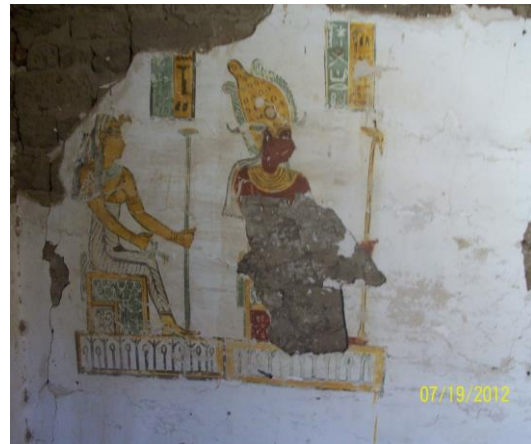
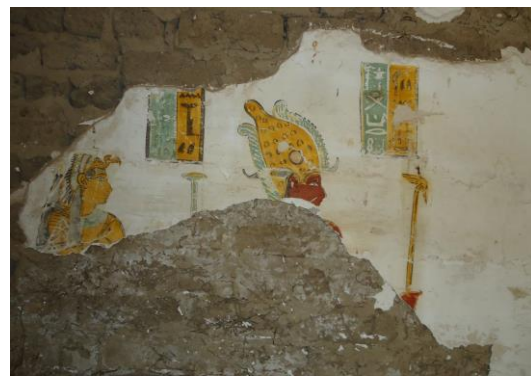
Recognised faunal activities are insects eating organic components of the plaster and adobe brick masonry or building nests in walls. There are examples, where insects have eaten fibrous components of the clay plaster like straw, and thus disconnecting the overlying

plaster layer resulting in a loss of plaster (figs.10, 11). Bats have chosen to live in tomb houses where they trigger decay processes by mechanical action and by their excrements, visible in salt efflorescence at some surfaces.

Figs.10+11: Remaining wall painting in GB 42, condition in 2012 and 2015

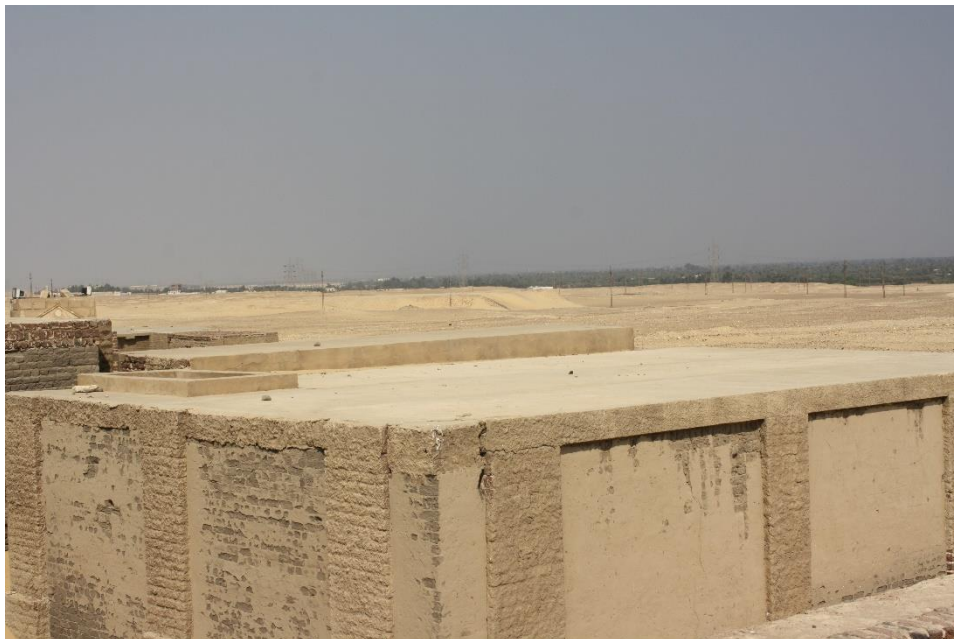
In some places it appears, that new walls were added to exteriors to bear the load of the new roof. Those support structures were built higher than the adobe walls, keeping a distance to the original mud brick wall (example: GB 11, 12, 13, figs.12, 13).

Fig.12: Exterior of GB 11, 12, 13, under one modern roof, supported by added pillars of burnt bricks

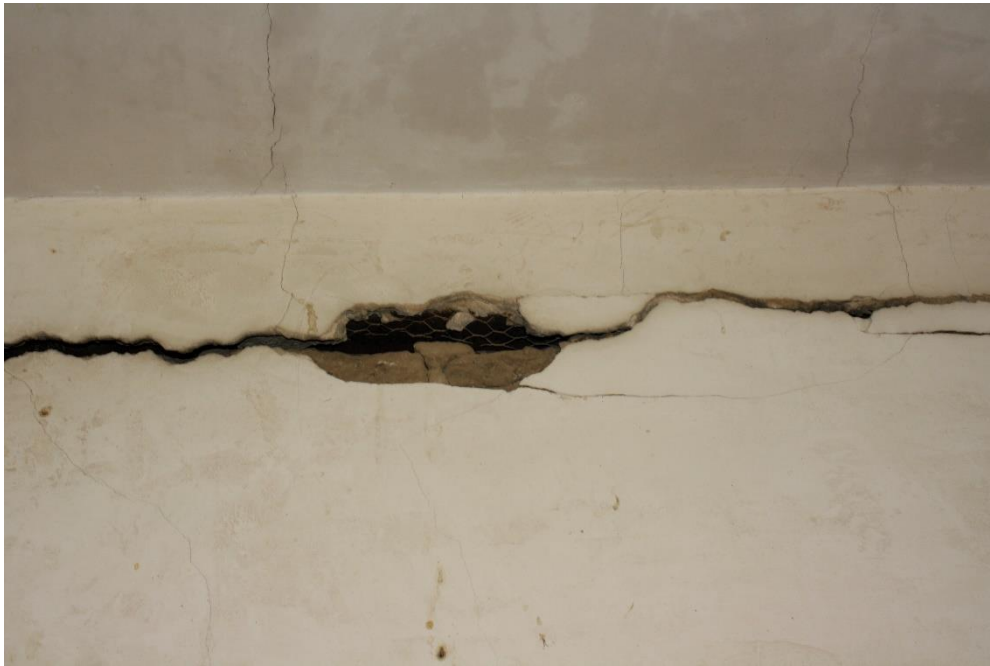
Fig.13: Interior of GB 13, second room, rear wall, a distance was kept between original adobe wall and new roof structure, bridged by metal mesh and plastered with white stiff render

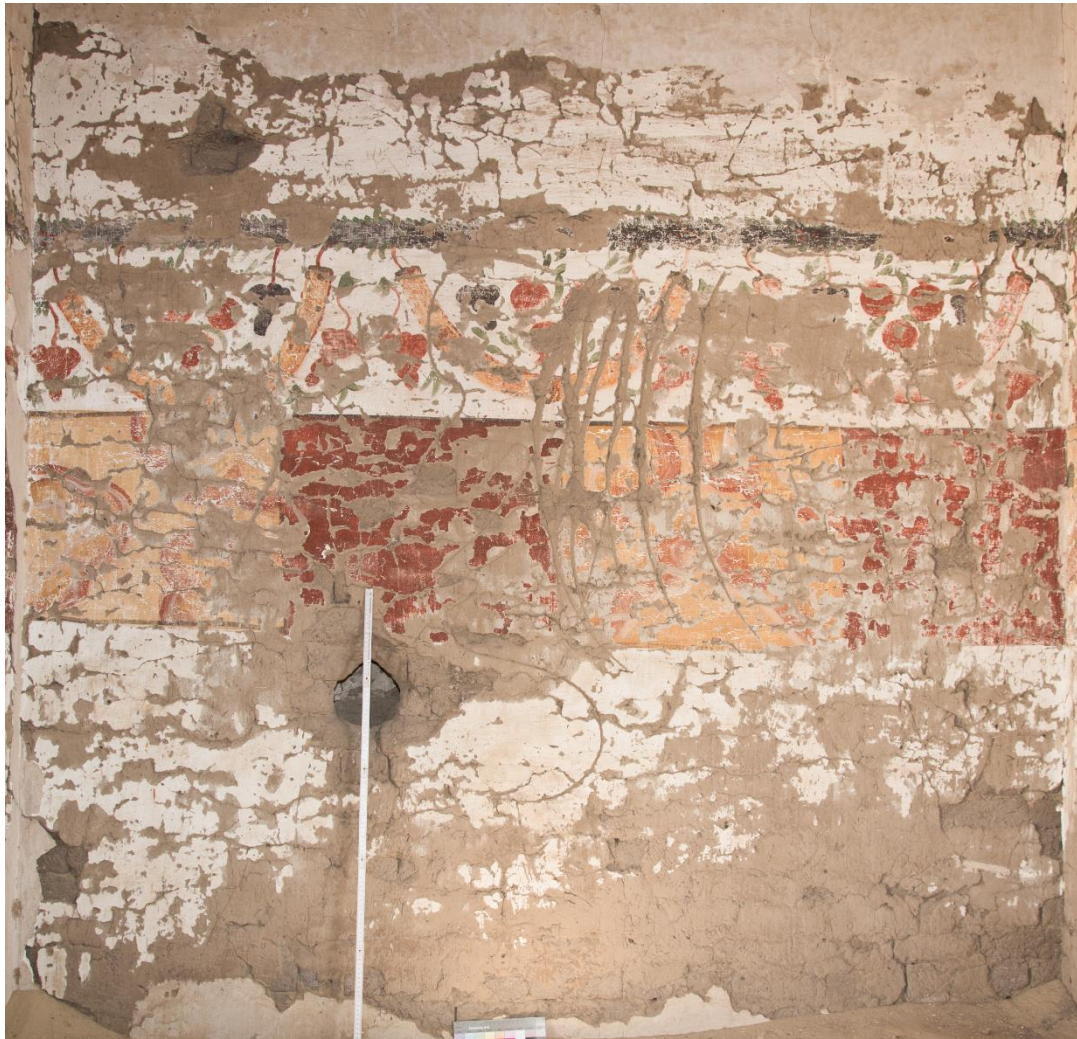
Other traces of destruction as scratched wall paintings, demolished interiors or an imprint of a ball tell their own story.

Fig.14: GB 24, human made scratches on wall surfaces
