Documentation - Field Schools in Tuna el-Gebel

Friederike Funke, 30.11.2018

In the necropolis in Tuna el-Gebel a German-Egyptian Field School Programme for conservation of wall paintings was performed in 2012, 2014, 2015 and 2018.¹ Here documentation was considered highly important and much time was taken to teach and practice this.

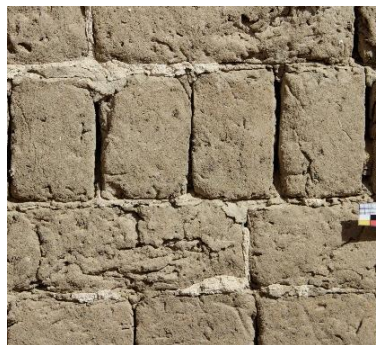
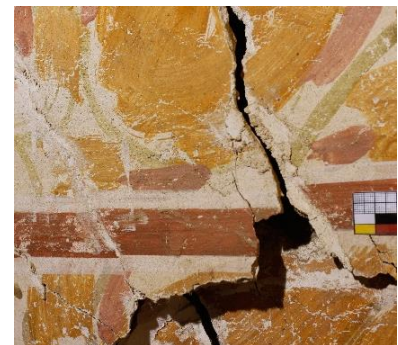
Example of description in the documentation glossary		
Brick wall repair, made of burned bricks for reconstruction of a wall in GB 21.	Mauerwerksergänzung aus gebrannten Ziegeln zur Rekonstruktion einer Wand in GB 21.	الصورة رقم اصلاح جدار من الطوب مصنوع من الطوب المحروق واعادة اصلاحه الجدار من موقع GB21

A short glossary was produced as a list of findings with a definition of the individual phenomena in German, English and Arabic and was attached to the graphic documentation.

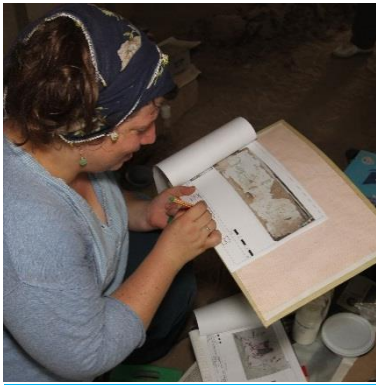
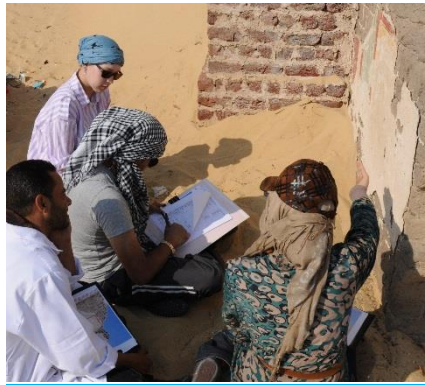
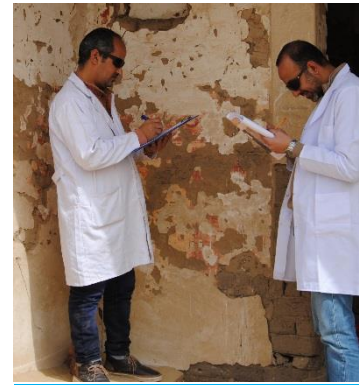
[photographic documentation](#)

The photographic documentation is always added to a written documentation. Photos capture the pre-state before emergency stabilization, document the process of conservation and the final state after emergency stabilization. It is also important to visualize technological and alteration phenomena regarding the overall situation as well as in details. Photos of the typical phenomena on site should be added to the glossary to give a better understanding of deterioration patterns.

The HAWK University of Applied Science Hildesheim archived all photos done on site and chose a meaningful selection included to the “final report” and to the “conservation-report” of each campaign.
