The Necropolis of Petosiris at Tuna el-Gebel

Final report of the season in spring of 2018

1. The field school for restorers (co-operation of the Ministry of Antiquities (MoA), Minya University, State Museum of Lower Saxony Hanover/Germany and supported by the University of Applied Sciences HAWK in Hildesheim, Germany)

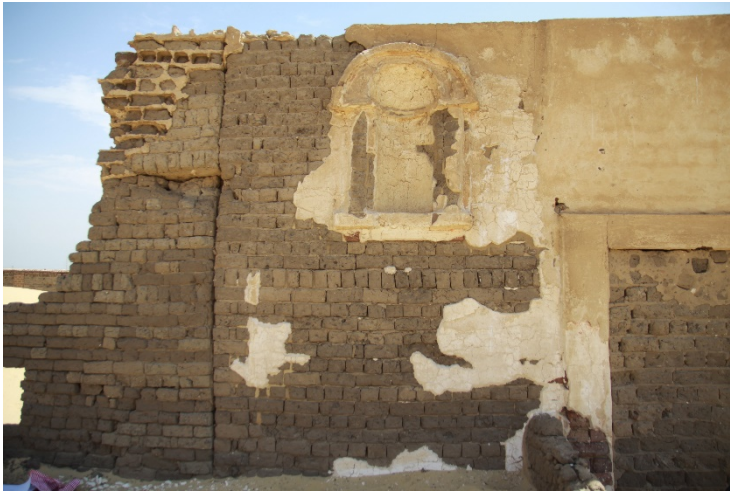
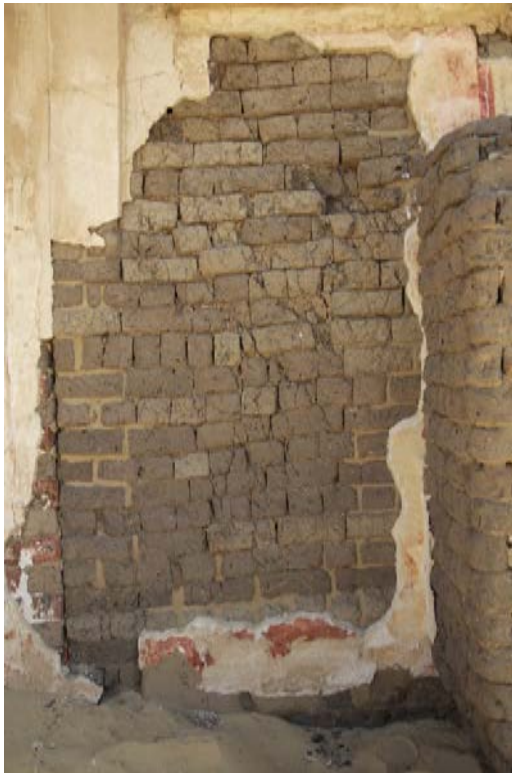
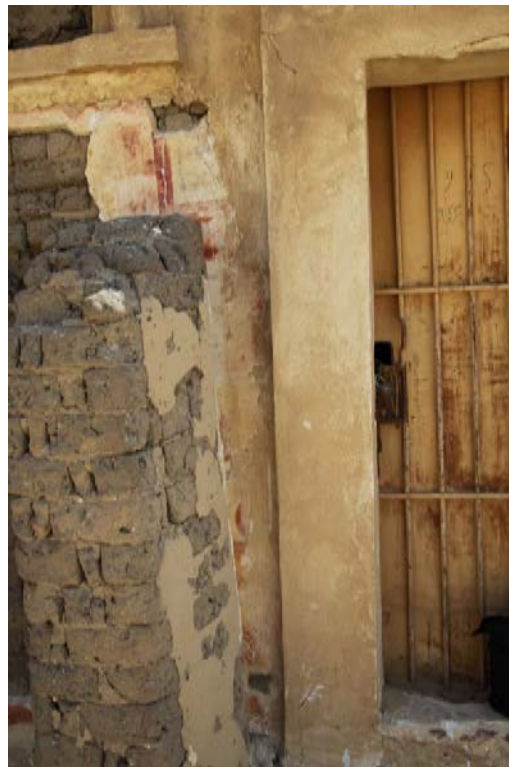
Figs.02,03,04:
Working areas of
GB27 outside,
after treatment

At the eastern facade of GB27 some original plaster with fragments of paint is remaining. Mainly red paint, but also hues of green and some fragments of ochre can be seen in the small niche on the left side. The original plaster is in dire need of stabilization. A comparison of the mapping of 2014 showed, that new losses of plaster have occurred.

The measures of the field school 2015 were continued. As many areas of plaster were detached from the wall, it had to be stabilized by rendering edges and the grout injections. With the help of syringes the grout could be injected through existing holes in the gabs between the detached plasters. The emergency conservation measures in this area could be completed.

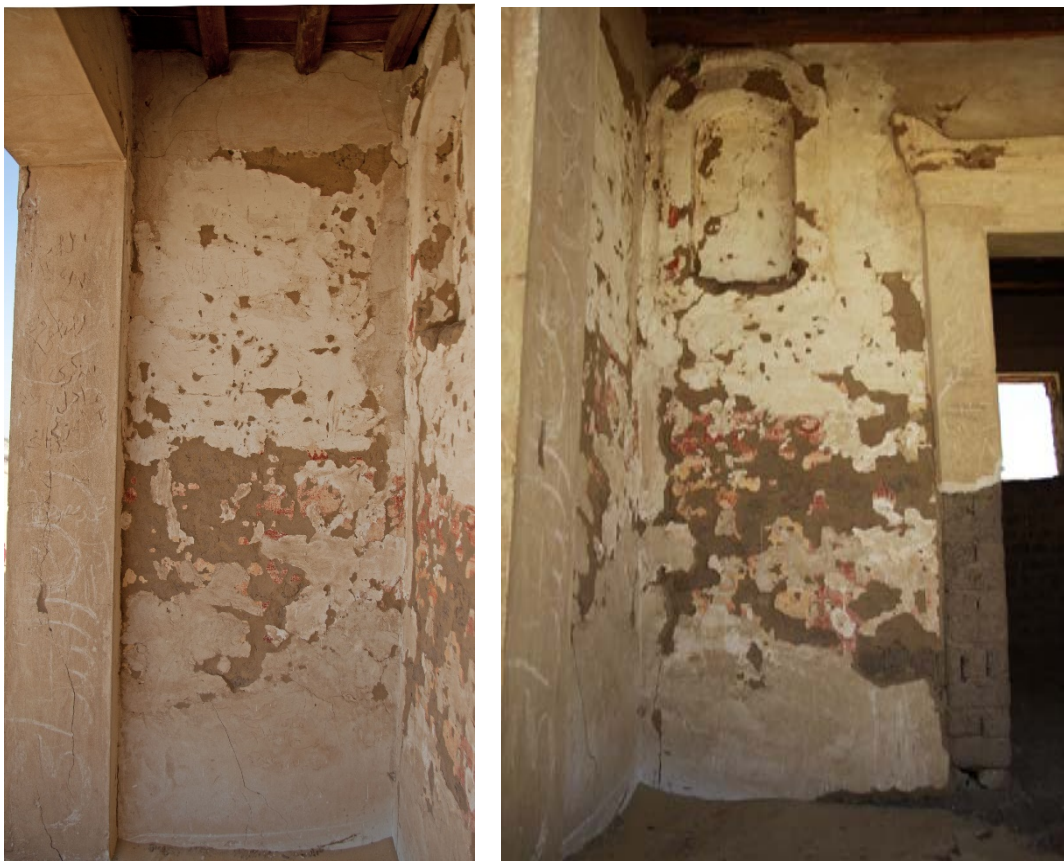
Figs. 05,06: GB24, antechamber north and east walls, after conservation

In GB 24 the wall paintings are executed on a fine lime layer (primer), applied on a thin mud plaster on a mud brick wall. The painting shows many little lost areas and the fine edges of the primer-layer are very fragile.

The measures of the field school 2015 were continued. Consolidation of the mud plaster was repeated, where it seemed necessary. Then the stabilization of endangered plaster edges with a conservation plaster was carried out. To consolidate areas with detached primer a very fine grout was injected underneath the thin layers. This tomb is freely accessible and therefore particularly endangered. It should be continually monitored.

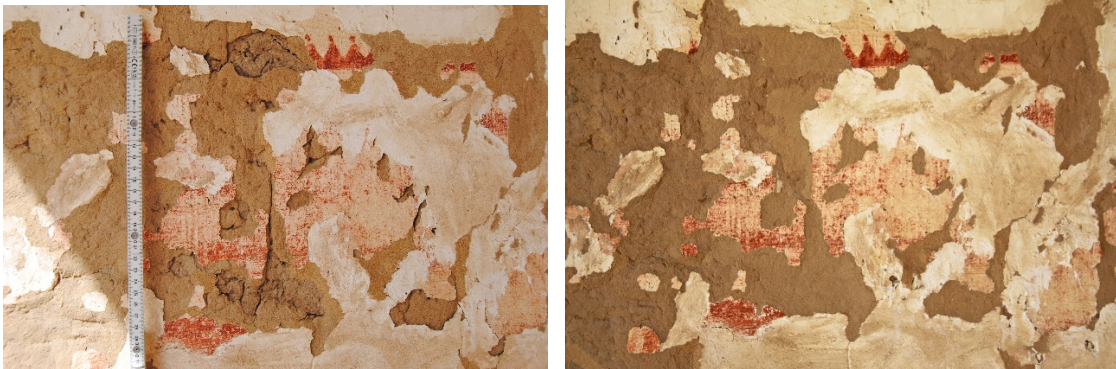
Figs.07,08: GB24, antechamber east wall, before and after treatment

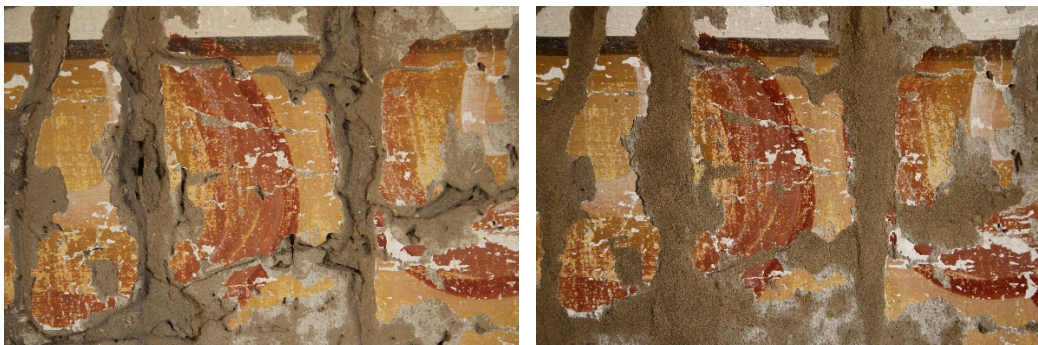
Figs. 09,10: GB24 inside,north wall,
before and after application of conservation plaster

This beautifully decorated tomb house is unfortunately open to access, and much destruction by vandalism can be seen here. The emergency conservation of the wall paintings started this year.

After careful dry cleaning with soft brushes, the stabilization of endangered plaster edges with a conservation plaster was carried out. The measures of this year could achieve a more stable situation by closing holes and cracks and securing edges with conservation plaster. The work has to be continued.

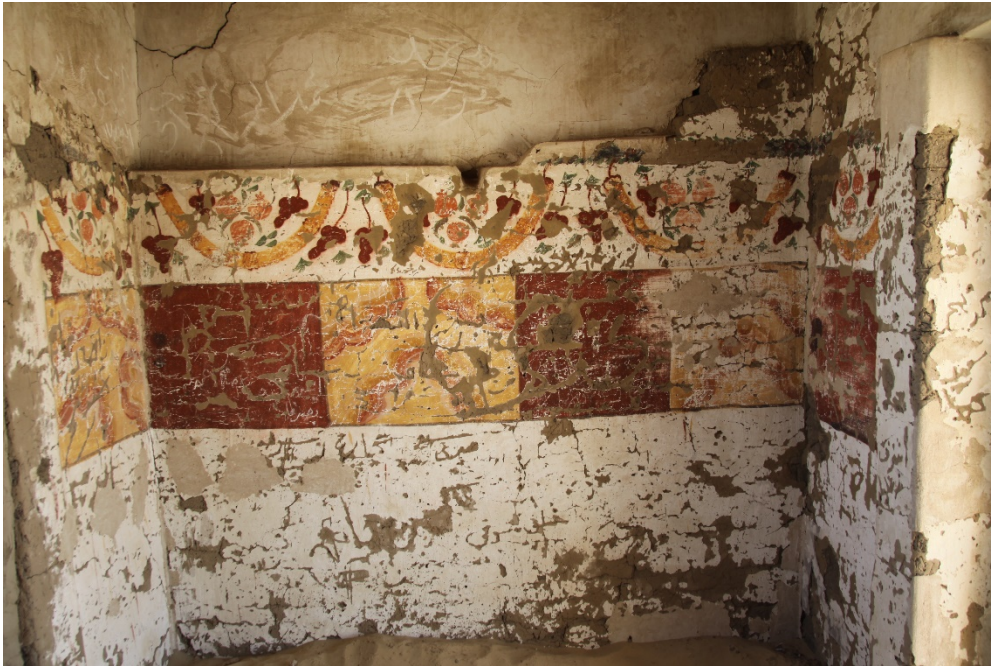
Fig.11: GB24 inside, south side after partial conservation

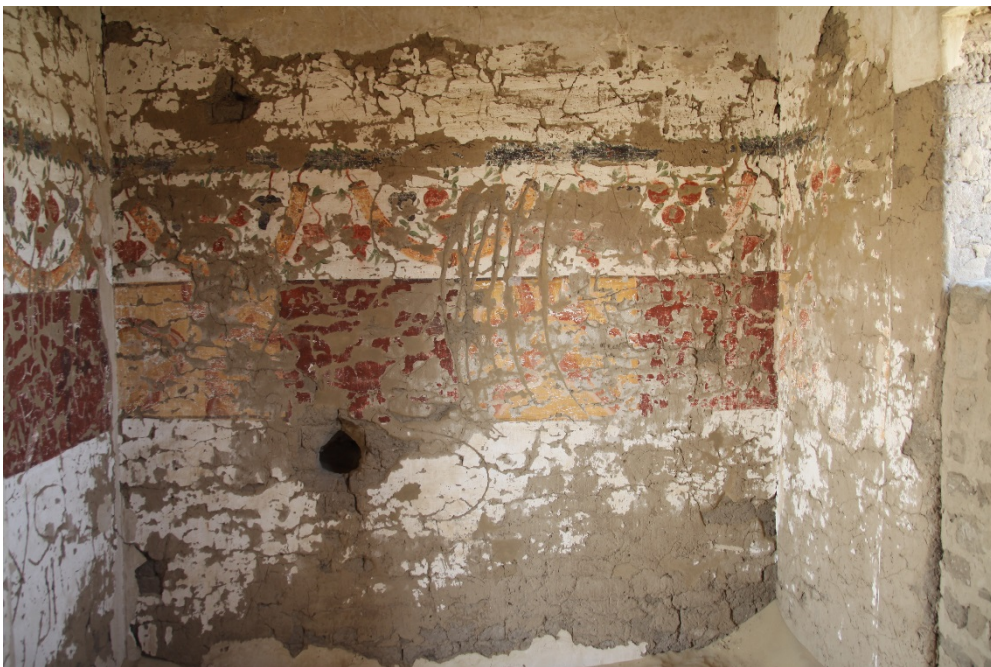
Fig.12: GB24 inside, northth side after partial conservation

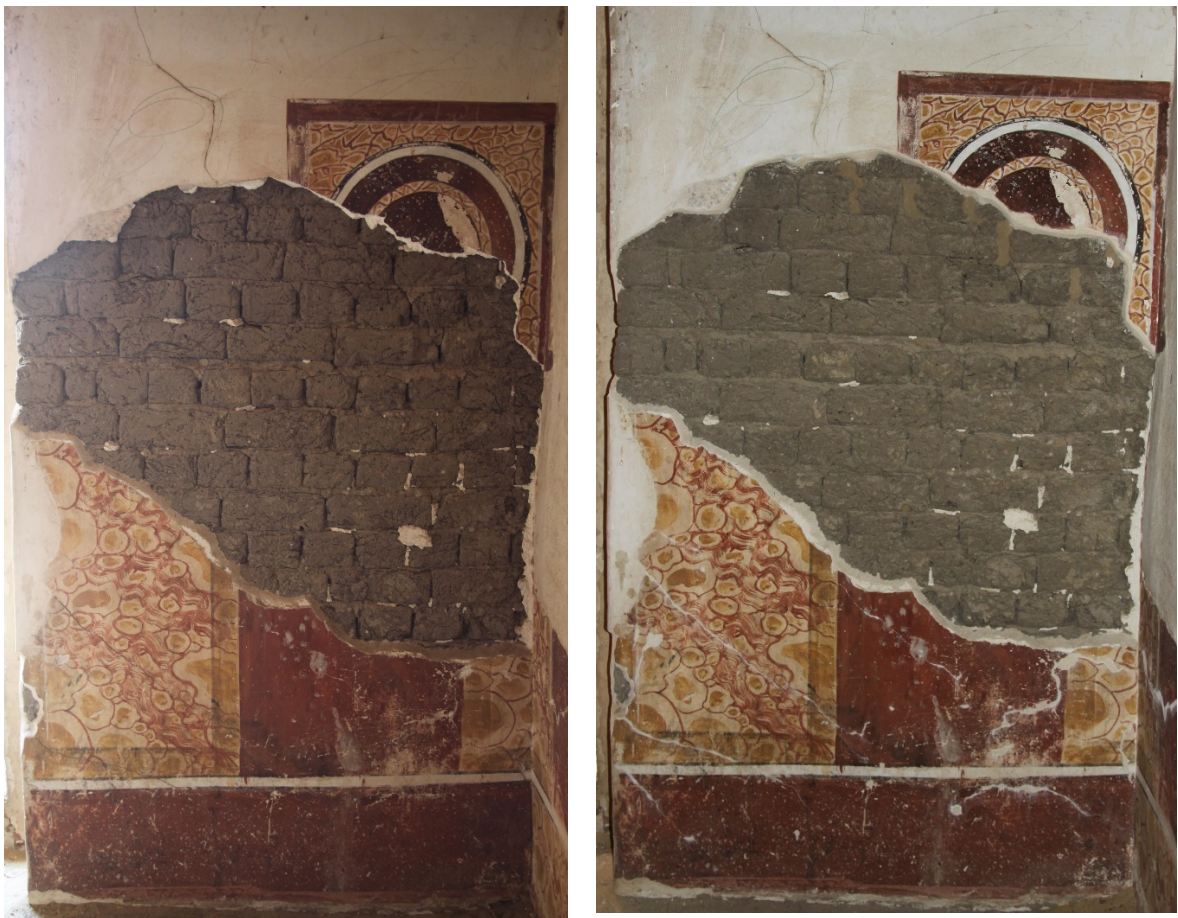
Figs.13,14: GB 16 first room, south wall, before and after conservation

The measures of the field school 2014 were continued. As many areas of plaster were detached from the wall, it had to be stabilized by rendering edges and grout injections. With the help of syringes the grout could be injected through existing holes in the gaps between the detached plasters and the brick wall.

The emergency conservation measures in this tomb could achieve a more stable situation. This tomb is freely accessible and therefore particularly endangered. It should be continually monitored.

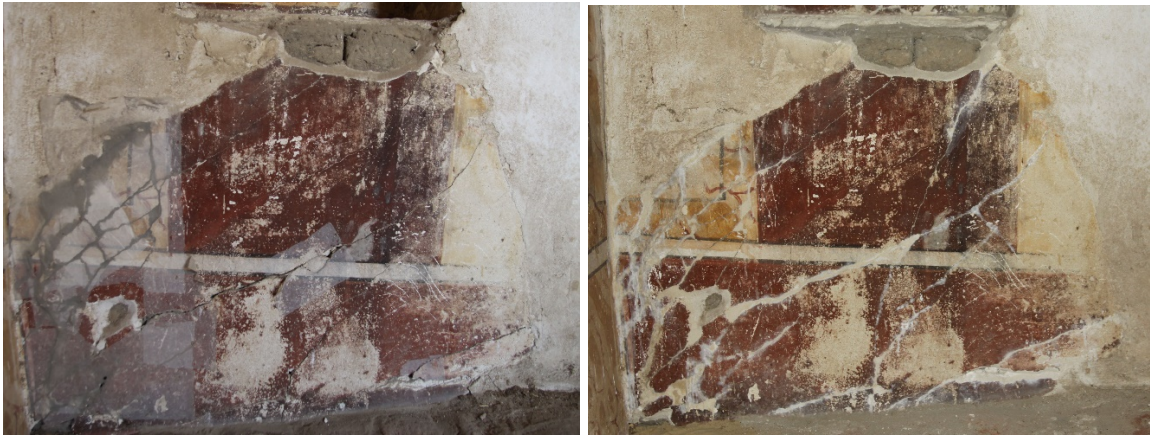
Figs.15,16: GB 16 first room, south wall, before and after grout injections; the Japanese paper facing could be removed after stabilization

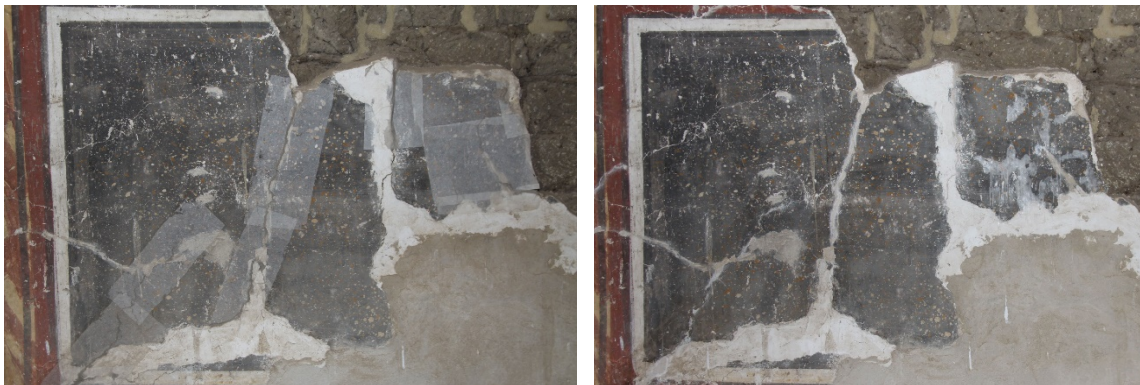
Figs.17,18: GB 13 first room, south-east wall, before and after grout injections; the Japanese paper facing could be removed after stabilization

In GB 13 the painted plaster is in many places detached from the mud brick walls and in danger of falling off. The measures of the field school 2015 were continued. The main task was to stabilize detached and instable parts of the plaster by grout injections, that filled and stabilized small cracks and big voids with two different recipes with grouts, designed for the needs at this site.

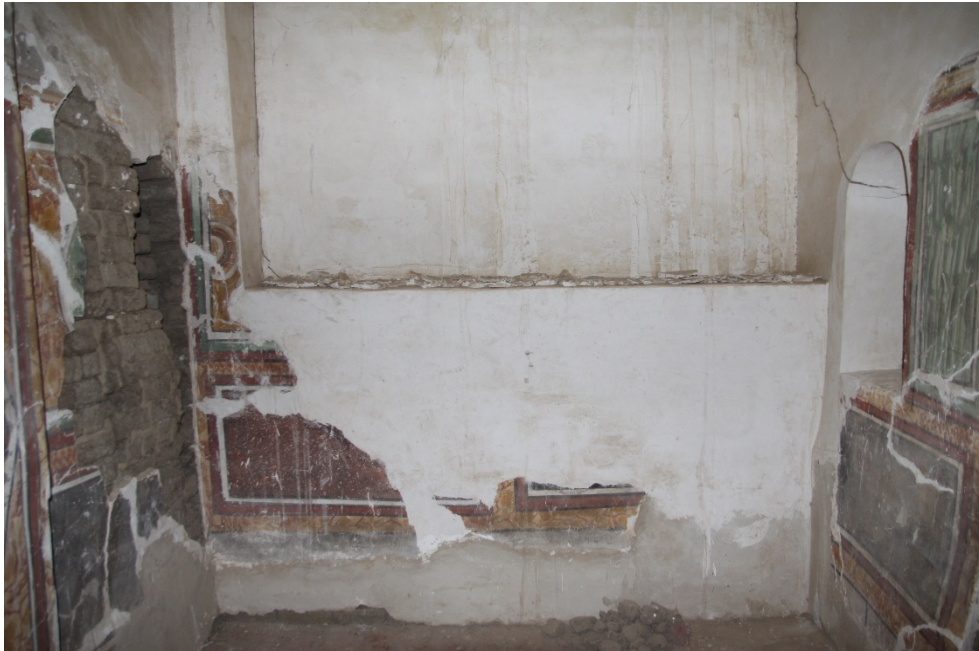
Figs.19: GB 13 first room, east wall, after conservation

The emergency conservation measures of the wall paintings in the first room could be completed. This tomb is locked and secured by a door.

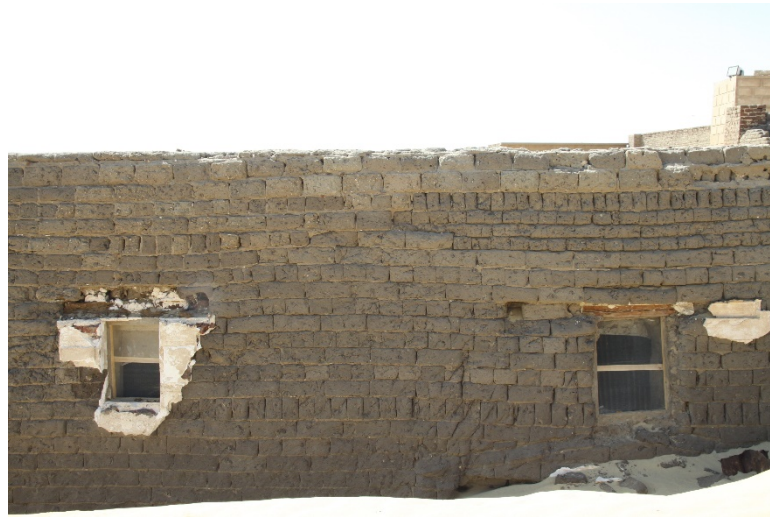
Fig.20: GB 29 north side (Egyptian house), windows were closed with mesh

In three places open windows were closed with mesh to prevent animals to enter.

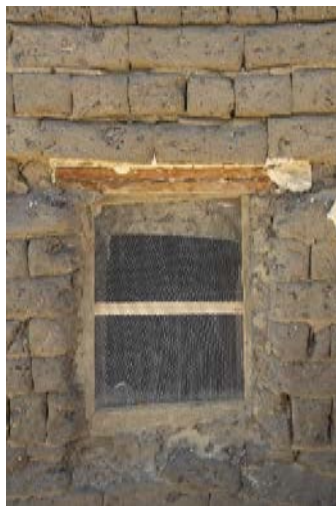
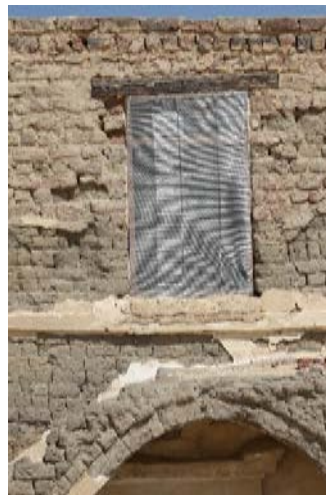
Figs.21, 22: GB 20 west side (Hermokrates) and GB 04 south side, windows were closed with mesh

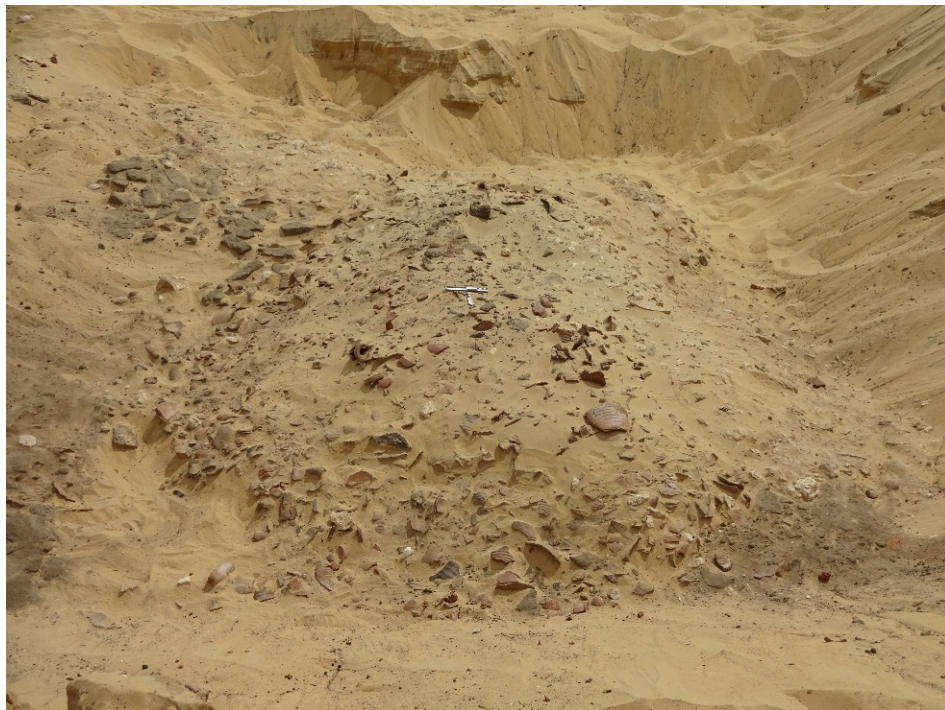
Fig. 25: The barrel vault from the north

From March 11th to 22nd, 2018 we started the first excavation south of the area excavated by Sami Gabra. During this season we found at least two structures: At first we discovered a barrel vault orientated from north to south that was collapsed in its southern part. From this area we saved some sherds in order to document and classify them during the next season. Most of them belong to the so-called kitchen ware, i.e. were used for the storage of food and the preparation of meals. Further south the sand is clean.

According to the elevation of the barrel vault and the missing structures on top of it, the building certainly had a ground floor only. As in Tuna el-Gebel the barrel vaults are generally orientated across, the entrances were presumably in the western and/or eastern wall.

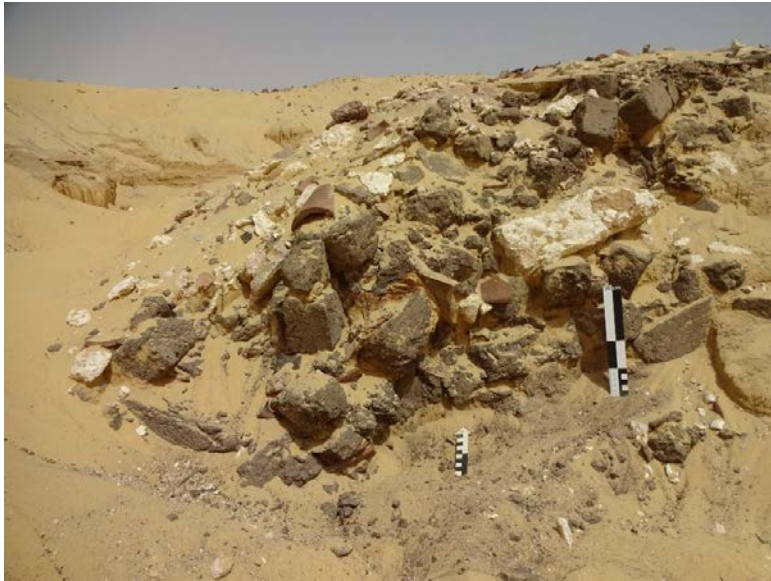
Fig. 26: The southwestern corner of the roof showing a mixture of adobe bricks, sherds, and limestones used for building the vault

The roofs consist of adobe bricks. The barrel vault has a high dome, and many sherds were caked with the mudbrick and may have served as “chinking sherds” to fill the gaps between the bricks of the vault for stabilization. Furthermore, many fragments from local stone are spread on the roof due to surface weathering of a neighbouring stone building. Probably also from there originate two blocks of local limestone found in the southwestern corner of the cleaned area. With a length of max. 60 cm they may have belonged to one of the earlier stone buildings (cf. GB 14: L 45-54 cm, H 23 cm or GB 15: L 44-53 cm, H 21 cm). As GB 14 and GB 15 were possibly built during the first century AD, the new building may be older, i.e. late Ptolemaic or early Roman period. The blocks are roughly chipped, as usually at Tuna el-Gebel during this period.

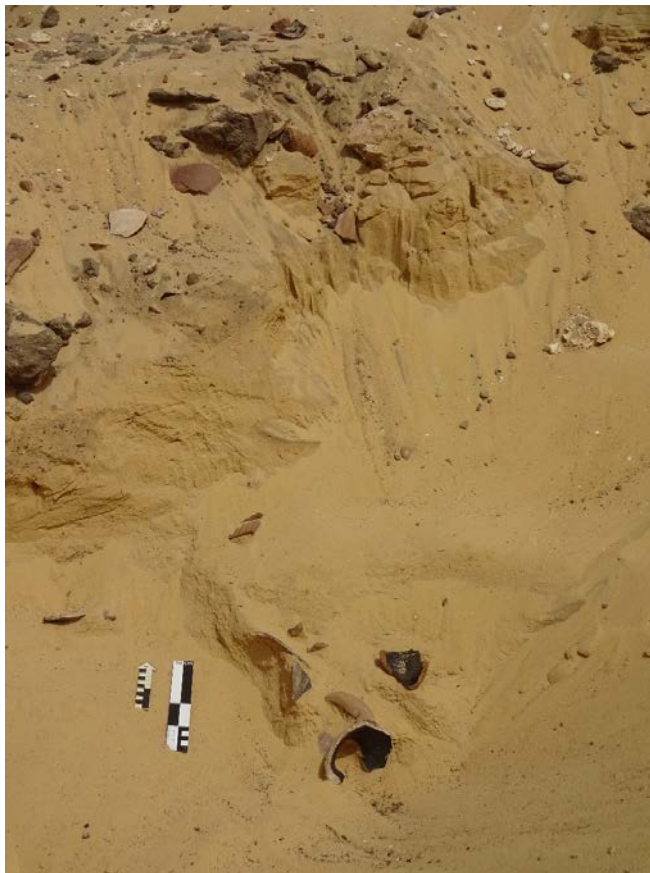
Fig. 27: Sherds found in the collapsed southern part of the barrel vault

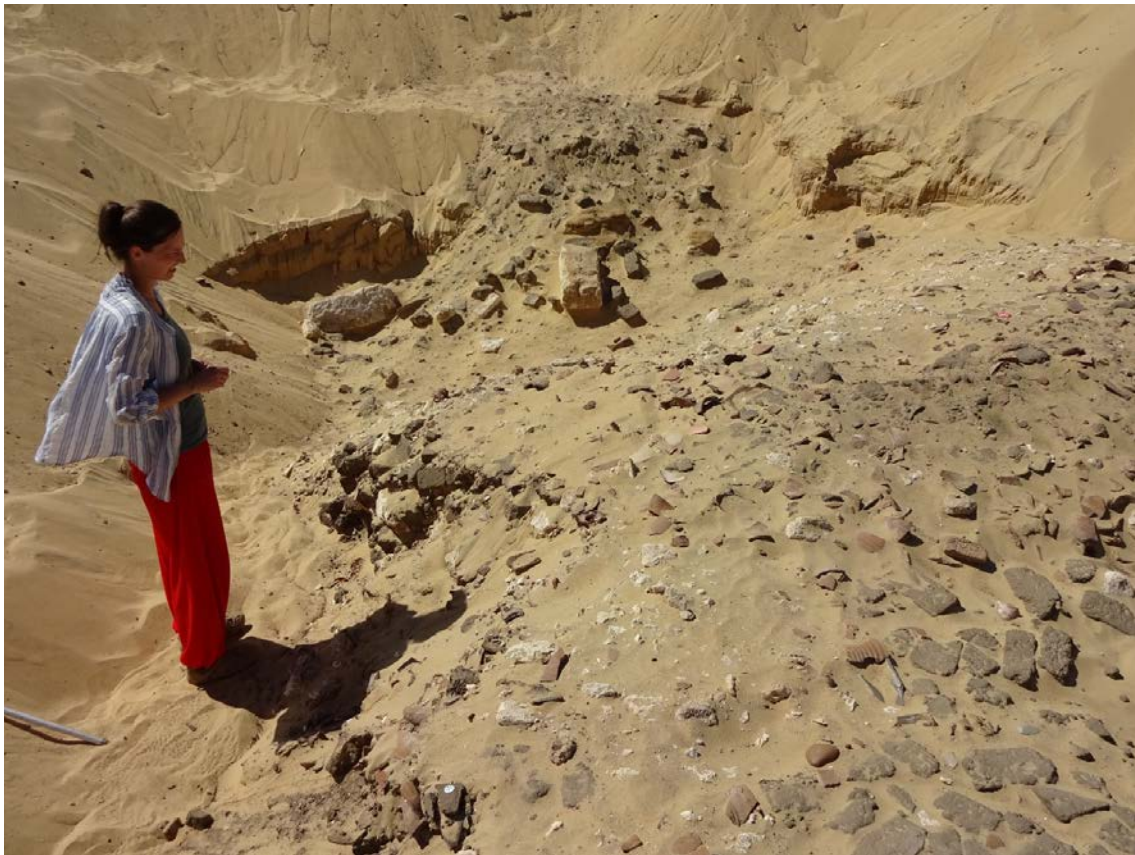
Fig. 28: Southern part of the barrel roof in the front and the second vault in the background

To the northwest we partly cleaned another vault from sand, while to the north we stopped working because of the big quantity of sand, which was not possible to be removed in such a short campaign.

While the known tomb houses had an attica zone surrounding the vault of the ground floor to permit the insertion of a floor for the second storey without endangering the vault below, the barrel vault does not seem to have such a boundary. Furthermore, the dome is unusually high, but still comparable to the vault of GB 4. As far as we may state now, the building seems to be undisturbed and damaged by sand only.

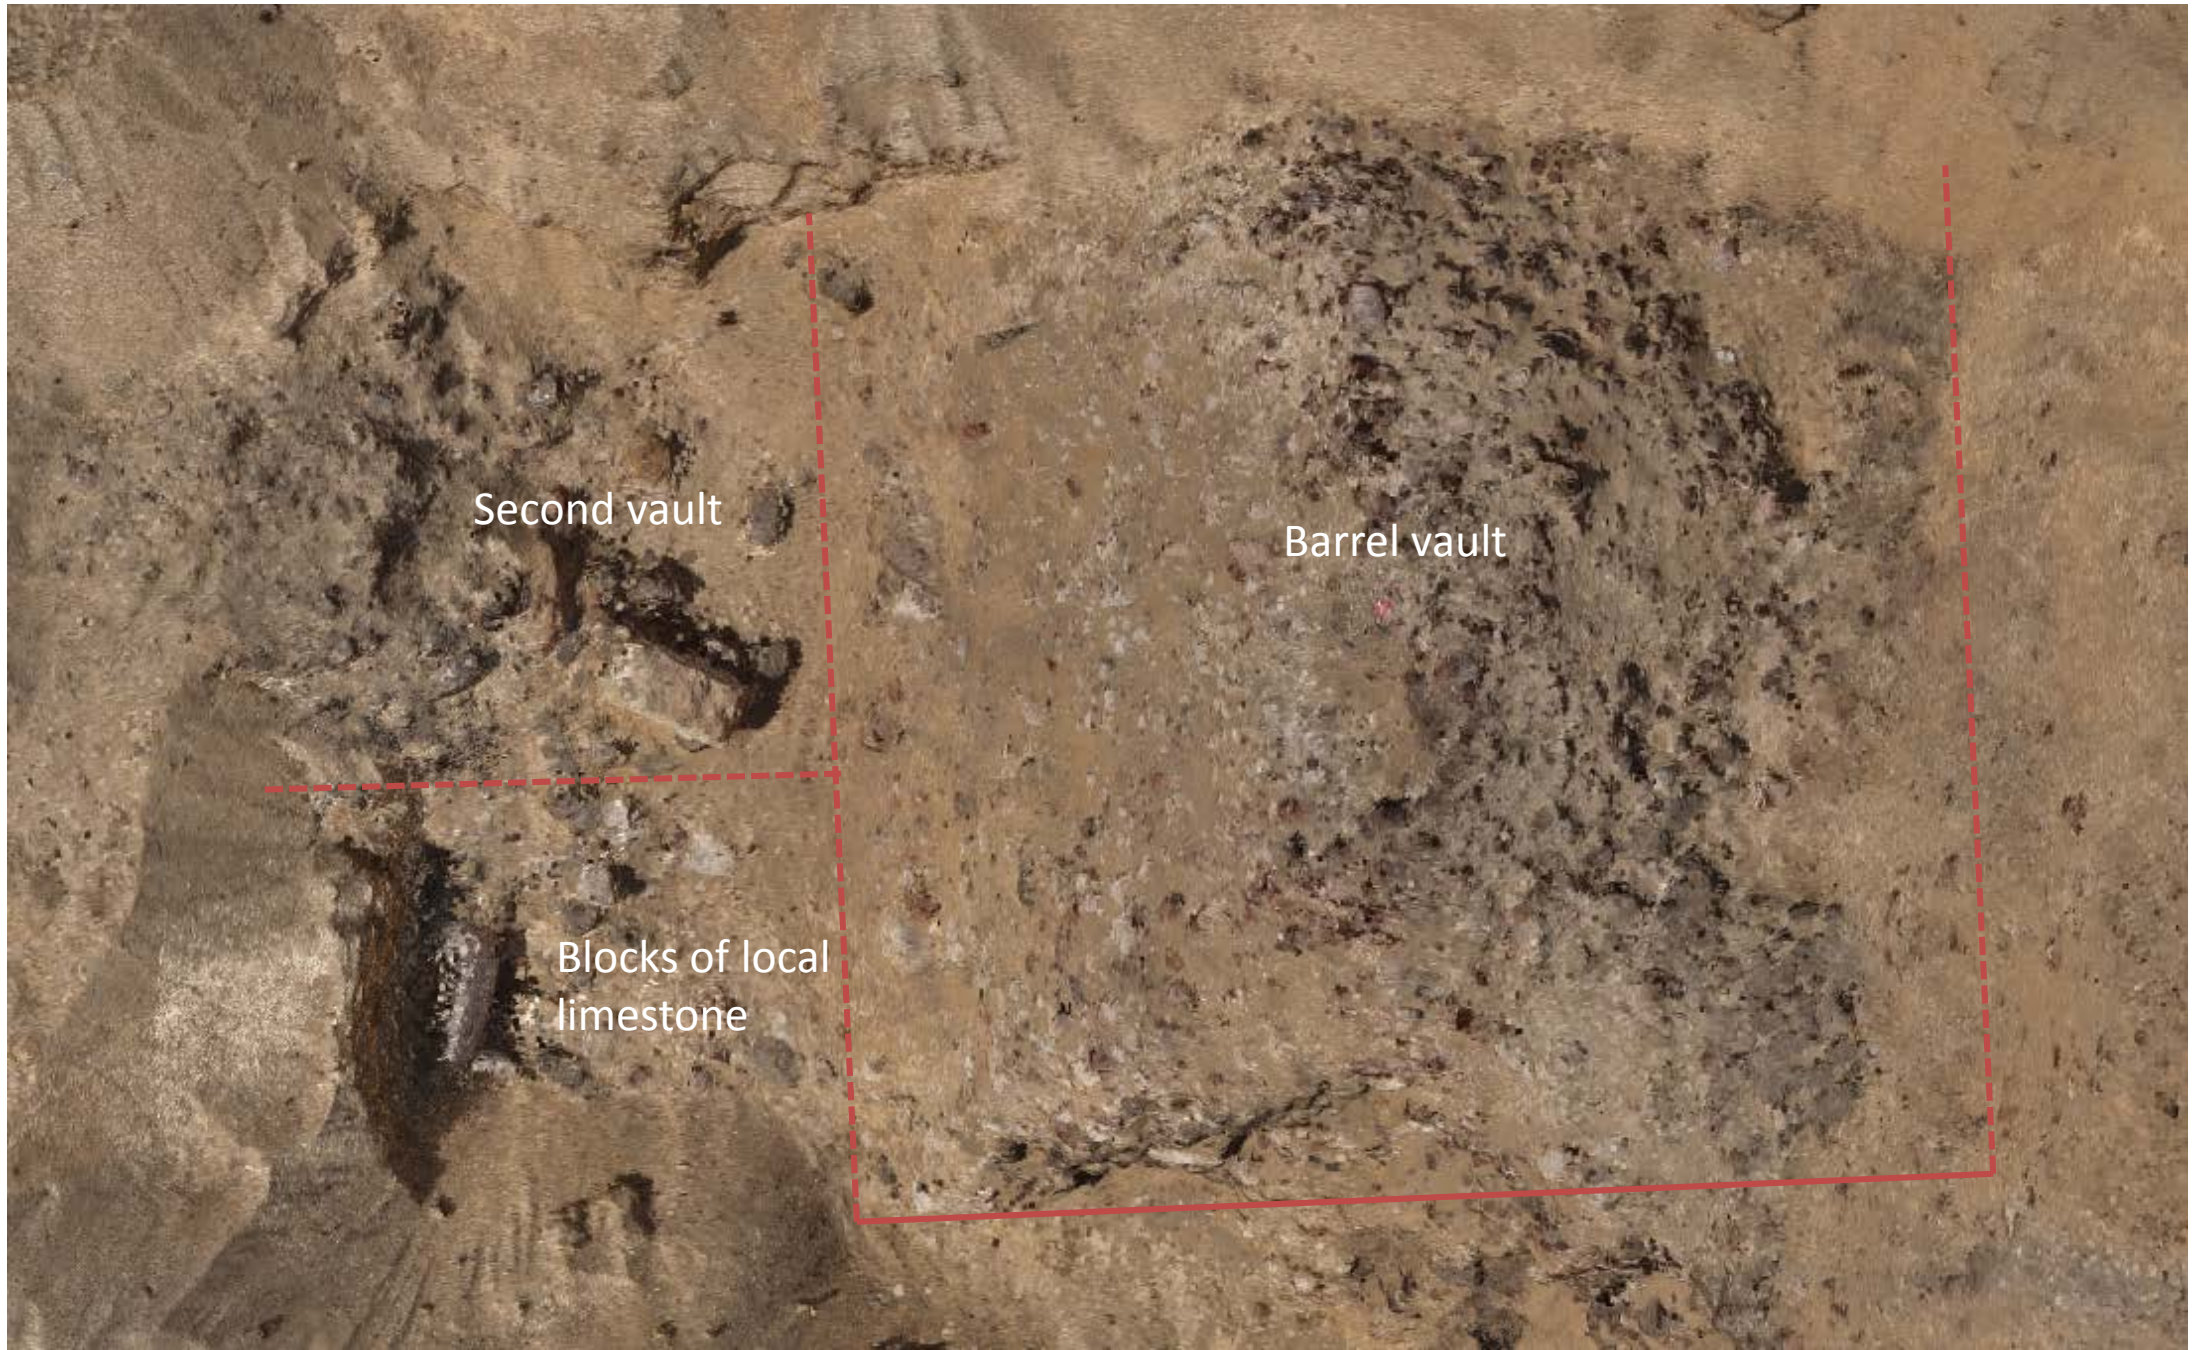
KUPPELAUFSICHT UND ANSICHT

Second vault

Barrel vault

Blocks of local
limestone

L: 51 cm
B: 24 cm
H: 22 cm

L: 60 cm
B: 23 cm
H: 25 cm

Maße ungebrannter
Lehmziegel
L: 20 cm
B: 9.5 cm
H: 7.5 cm
