## Tomb no. GB 27 (Gabra no. M 09c/SE) facade

## Tomb no. GB 27 (Gabra no. M 09c/SE) inside

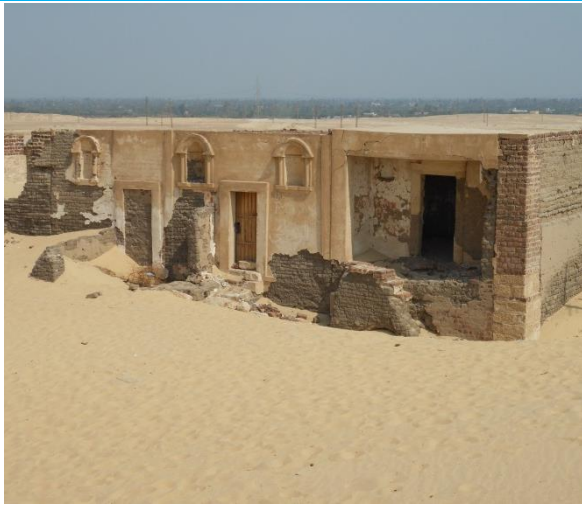
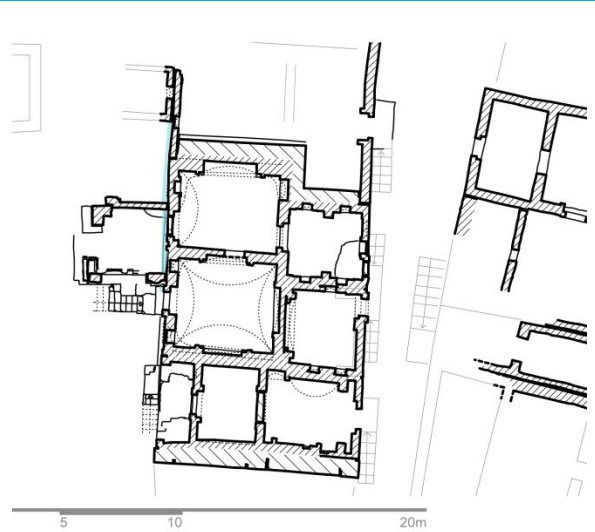
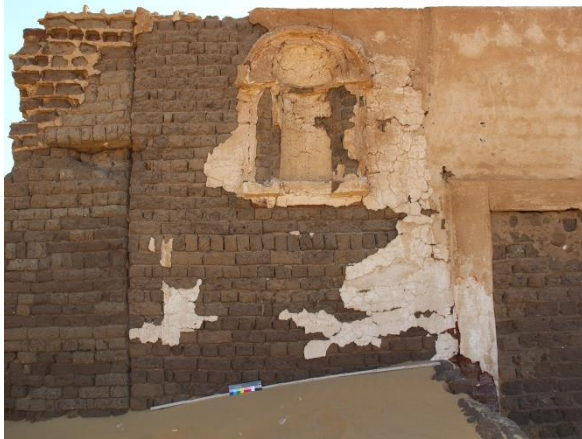
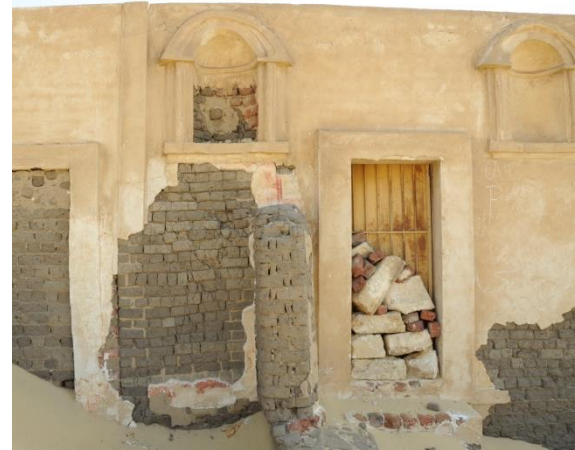
A tomb house made of adobe masonry. Today the rooms on the second floor are accessible and the structures of the first floor are completely covered by desert sand. The historic door of this tomb house is bricked up. The facade is decorated with little niches framed with stucco.

Inside and outside the adobe masonry is coated with two layers of lime plaster with a whitewash on the top. Fragments of red and green colour are a hint that the niches have been decorated colourful in the past.

Condition before treatment	
<p>The plaster layers on the facade are partially lost and expose the sun-dried clay brick masonry (adobe). Where visible the adobe masonry shows a structurally destabilised and sanding surface. Parts of the joints are lost.</p> <p>The architectural surface is lined with cracks. Additionally, the plaster layers are detached from the adobe masonry, being endangered to falling off. Unfortunately, only meagre fragments of the painted decoration have survived.</p> <p>An intervention is necessary to halt active deterioration and preserve the original plaster.</p>	
Treatment	
<p>The following steps of emergency measures were done in the field schools of 2014, 2015 and 2018. The main goal was to stabilize the historic plaster layers. The consolidation of the adobe masonry surface next to the preserved plasters provided a solid structure for the treatments to follow. In addition, lost joints were infilled.</p> <p>The plaster layers were stabilized by edging detached fragments. The conservation mortar contains cellulose-ether as binder. To improve the bondage between coat and support, voids were filled by grout injections based on a silica binder. Due to the outdoor situation all conservation plasters were finally structurally strengthened with a silica binder.</p> <p>To learn about details of all conservation steps and materials please refer to the link “treatment” to be found on the front page introduction.</p>

Emergency measures have been carried out to prevent further decay. The facade is exposed to the elements and human action. In this respect, it would be desirable to establish maintenance and monitoring programme for the future.

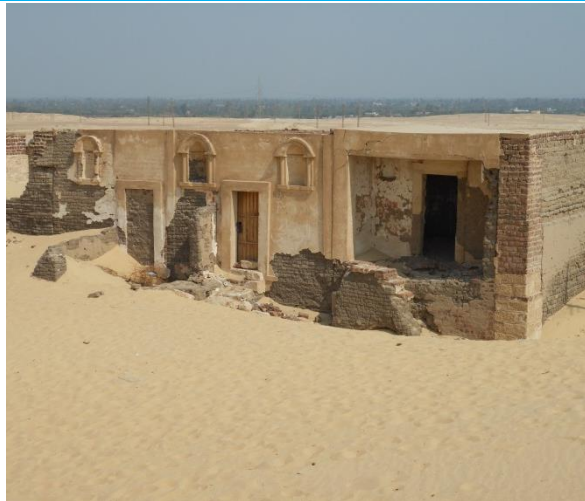
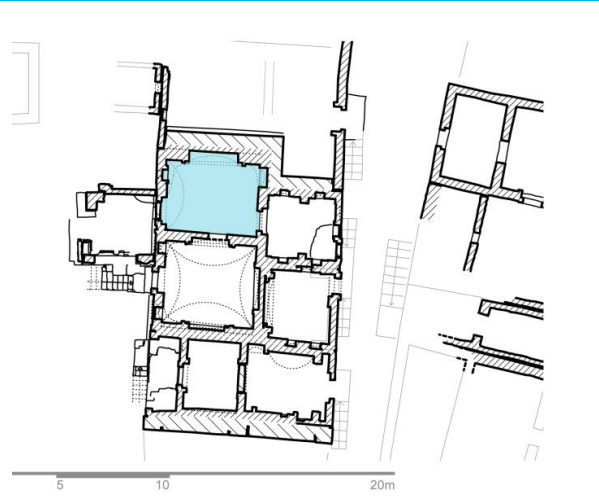
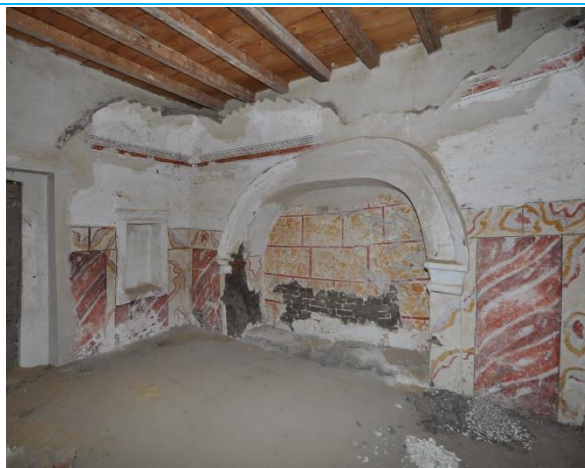
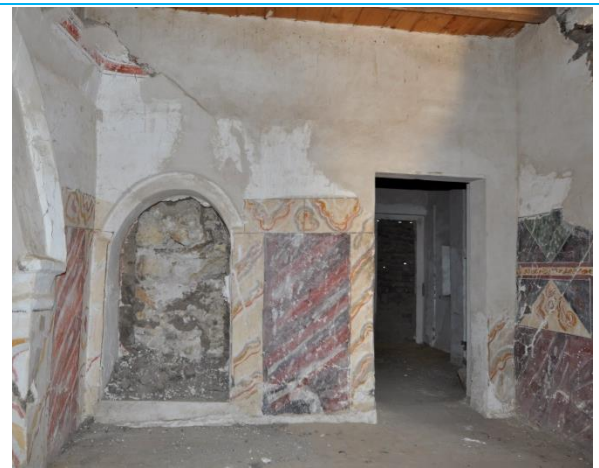
The plaster layers, especially on the northern wall, are partially lost and expose the sun-dried clay brick masonry (adobe). Where visible, the adobe masonry shows a structurally destabilised and sanding surface. There is a bigger damage in the masonry structure in the eastern frame of the big arched niche. Plaster fragments can be found on the floor below the walls.

The architectural surface is lined with cracks. Additionally, the plaster layers are detached from the adobe masonry, being endangered to falling off. In particular, the plaster layers in the big arched niche are particularly fragile. Collapsed plaster fragments could be found on the floor.

The paint layers are reduced. Partially the paint layers show deterioration phenomena like powdering. There is a layer of dust on the whole structure and a layer of bat excrements on the floor.

An intervention is necessary to halt active deterioration and preserve the original plaster and wall painting.
