# Tomb no. GB 19 (Epimachos)

## Description of the interior design

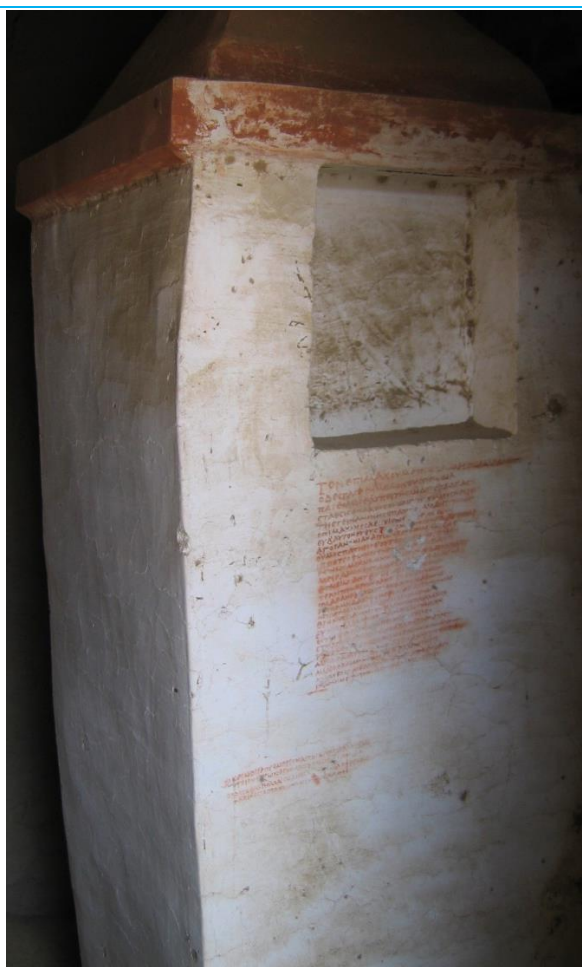
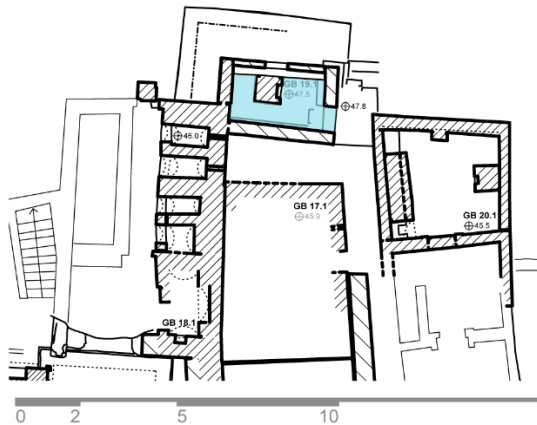
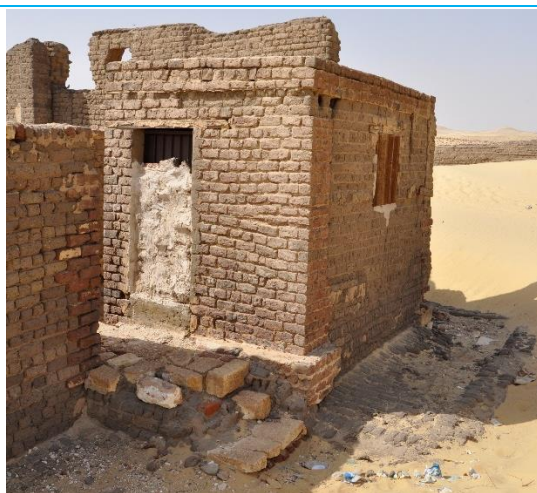
A stuccoed and painted tomb stele in a shelter house built by adobe masonry. The stele is built into the northern wall, so three sides are visible. The stele core is constructed of adobe masonry covered with a lime plaster finished with whitewash. On the front side the stele is decorated with red Greek inscriptions underneath a small niche.
